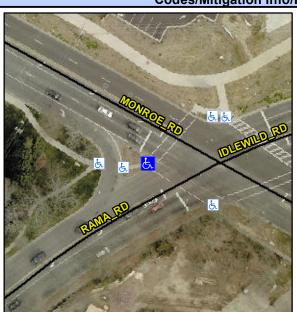
| | ı |
|---|---|
| PROW/ADA: | 1 |

| Comp | liance Description | Data | Comp | liance Description | Data |
| N/A | Ramp Length (in) | 63.0 | No | Ramp Slope (%) | 9.6 |
