Access Compliance Report

Public Rights-of-Way

(Curb Ramps)

Intersection ID: 12695	Main Street: S_CALDWELL_ST	Cross Street: E TRADE ST	Location: NE
ADA ID: F4F93901A1B6	Ramp Type: Perp	Initial Pass/Fail: Fail	Overall Compliance: No
Codes/Mitigation Info/Possible Solution			Severity Score: 22.5
			Field Measurements/Component Compliance

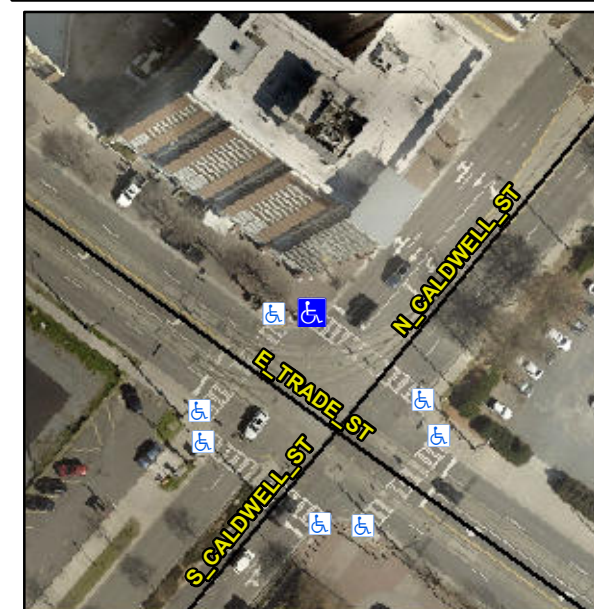
Not Found, R304.5.1, R304.2.2, R304.5.3

Compliance	Description	Data	Compliance	Description	Data
N/A	Ramp Length (in)	66.0	No	Ramp Slope (%)	8.6
No	Ramp Width (in)	47.0	No	Ramp XSlope (%)	3.4
N/A	Flare Type LT	N/A	N/A	Flare Type RT	N/A
N/A	Flare Slope LT (%)	N/A	N/A	Flare Slope RT (%)	N/A
N/A	Flare Traversable LT?	N/A	N/A	Flare Traversable RT?	N/A
N/A	Landing Length (in)	N/A	N/A	DWS Provided?	N/A
N/A	Landing Width (in)	N/A	N/A	DWS Contrast?	N/A
N/A	Landing Slope (%)	N/A	N/A	DWS Length (in)	N/A
N/A	Landing X Slope (%)	N/A	N/A	DWS Full Width?	N/A
N/A	Landing Curb? (Y/N)	N/A	N/A	DWS Offset (in)	N/A
N/A	Shared Landing?	N/A			
N/A	Gutter Ponding?	N/A	N/A	Gutter Slope (%)	N/A
N/A	Gutter Lip Ht (in)	N/A	N/A	Gutter X Slope (%)	N/A
N/A	Painted X Walk1?	Yes	N/A	Painted X Walk2?	N/A
	X Walk 1 Direction	To SE		X Walk 2 Direction	N/A
N/A	X Walk 1 Width (in)	112.0	N/A	X Walk 2 Width (in)	N/A
	X Walk 1 Slope (%)	1.4		X Walk 2 Slope (%)	N/A
	X Walk 1 X Slope (%)	3.0		X Walk 2 X Slope (%)	N/A

N/A	Ramp inside XWalk1?	Yes	N/A	Ramp inside XWalk2?	N/A
	Road Slope (%)	N/A	N/A	Clear Space?	N/A
	Road X Slope (%)	N/A	N/A	Clear Space to XWalk (in)	N/A
N/A	Any Obstructions?	N/A	N/A	Storm Grate/Utility Hazard?	N/A
	Obstruction Type			Storm Grate/Utility Type	
		N/A			N/A
			Yes	Surface Condition? (G/P)	Good

Possible Solutions:

Remove & Replace Entire Ramp.

Total Cost: \$ 1850.00
