Access Compliance Report

Public Rights-of-Way

(Curb Ramps)

Intersection ID: 12570	Main Street: HARRISBURG_RD	Cross Street: STARNES_RANDALL_RD	Location: W
ADA ID: F5012D6E2971	Ramp Type: Perp	Initial Pass/Fail: Fail	Overall Compliance: No
Severity Score: 10			
Codes/Mitigation Info/Possible Solution		Field Measurements/Component Compliance

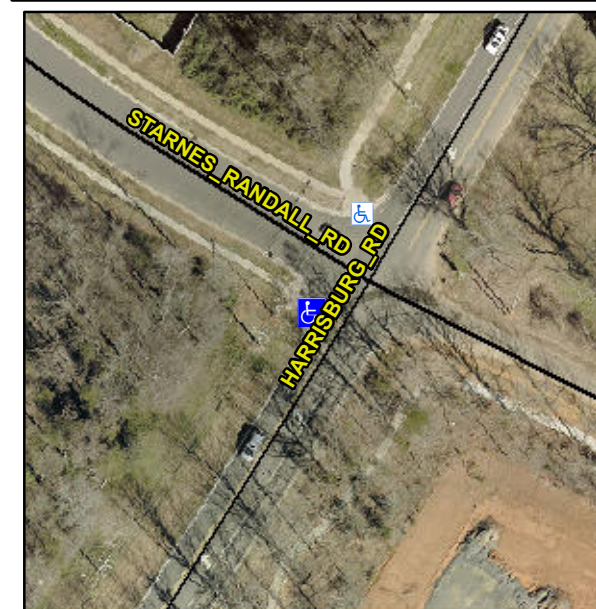
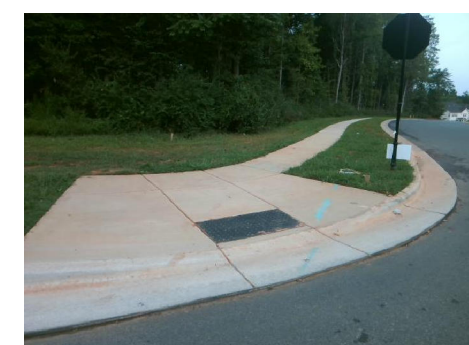
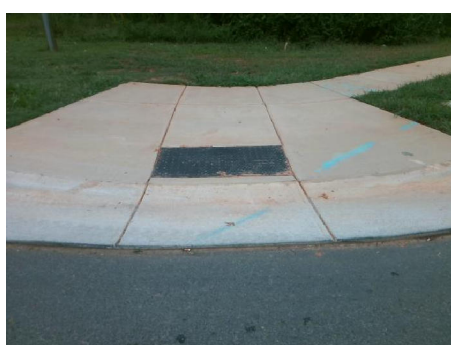
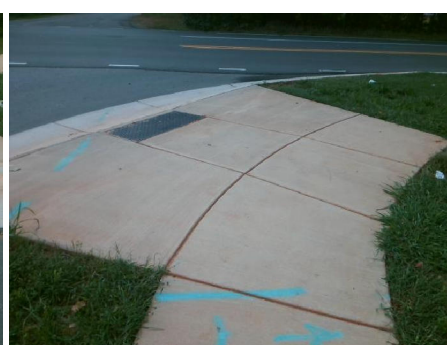
Not Found, R304.5.1, R304.5.3

Compliance	Description	Data	Compliance	Description	Data
N/A	Ramp Length (in)	83.5	Yes	Ramp Slope (%)	5.2
No	Ramp Width (in)	45.5	No	Ramp XSlope (%)	2.1
N/A	Flare Type LT	N/A	N/A	Flare Type RT	N/A
N/A	Flare Slope LT (%)	N/A	N/A	Flare Slope RT (%)	N/A
N/A	Flare Traversable LT?	N/A	N/A	Flare Traversable RT?	N/A
N/A	Landing Length (in)	N/A	N/A	DWS Provided?	N/A
N/A	Landing Width (in)	N/A	N/A	DWS Contrast?	N/A
N/A	Landing Slope (%)	N/A	N/A	DWS Length (in)	N/A
N/A	Landing X Slope (%)	N/A	N/A	DWS Full Width?	N/A
N/A	Landing Curb? (Y/N)	N/A	N/A	DWS Offset (in)	N/A
N/A	Shared Landing?	N/A			
N/A	Gutter Ponding?	N/A	N/A	Gutter Slope (%)	N/A
N/A	Gutter Lip Ht (in)	N/A	N/A	Gutter X Slope (%)	N/A
N/A	Painted X Walk1?	No	N/A	Painted X Walk2?	N/A
	X Walk 1 Direction	To NE		X Walk 2 Direction	N/A
N/A	X Walk 1 Width (in)	N/A	N/A	X Walk 2 Width (in)	N/A
	X Walk 1 Slope (%)	2.3		X Walk 2 Slope (%)	N/A
	X Walk 1 X Slope (%)	2.7		X Walk 2 X Slope (%)	N/A

N/A	Ramp inside XWalk1?	N/A	N/A	Ramp inside XWalk2?	N/A
	Road Slope (%)	N/A	N/A	Clear Space?	N/A
	Road X Slope (%)	N/A	N/A	Clear Space to XWalk (in)	N/A
N/A	Any Obstructions?	N/A	N/A	Storm Grate/Utility Hazard?	N/A
	Obstruction Type			Storm Grate/Utility Type	
		N/A			N/A
			Yes	Surface Condition? (G/P)	Good

Possible Solutions:

Remove & Replace Entire Ramp.
