Access Compliance Report

Public Rights-of-Way

(Curb Ramps)

Intersection ID: 45517	Main Street: BUGGY_HORSE_RD	Cross Street: MEADOW_BOTTOM_RD	Location: E
ADA ID: F5115BC4932C	Ramp Type: Perp	Initial Pass/Fail: Fail	Overall Compliance: No
Codes/Mitigation Info/Possible Solution		Field Measurements/Component Compliance

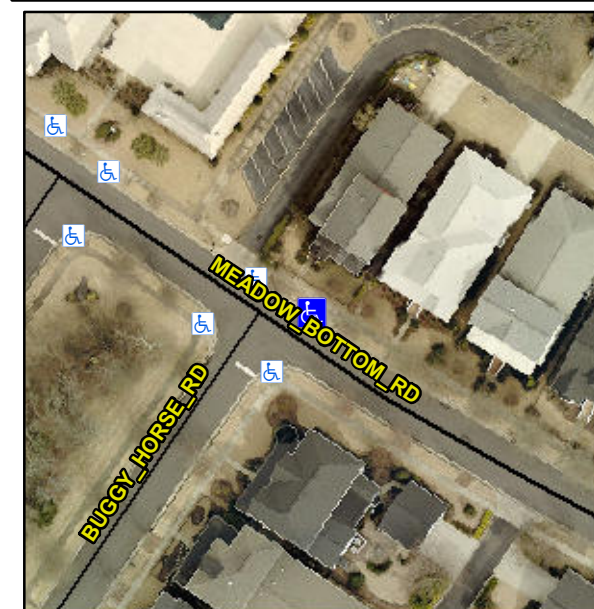
Not Found, R304.2.2

Compliance	Description	Data	Compliance	Description	Data
N/A	Ramp Length (in)	72.0	No	Ramp Slope (%)	9.7
Yes	Ramp Width (in)	48.0	Yes	Ramp XSlope (%)	3.7
N/A	Flare Type LT	N/A	N/A	Flare Type RT	N/A
N/A	Flare Slope LT (%)	N/A	N/A	Flare Slope RT (%)	N/A
N/A	Flare Traversable LT?	N/A	N/A	Flare Traversable RT?	N/A
N/A	Landing Length (in)	N/A	N/A	DWS Provided?	N/A
N/A	Landing Width (in)	N/A	N/A	DWS Contrast?	N/A
N/A	Landing Slope (%)	N/A	N/A	DWS Length (in)	N/A
N/A	Landing X Slope (%)	N/A	N/A	DWS Full Width?	N/A
N/A	Landing Curb? (Y/N)	N/A	N/A	DWS Offset (in)	N/A
N/A	Shared Landing?	N/A			
N/A	Gutter Ponding?	N/A	N/A	Gutter Slope (%)	N/A
N/A	Gutter Lip Ht (in)	N/A	N/A	Gutter X Slope (%)	N/A
N/A	Painted X Walk1?	No	N/A	Painted X Walk2?	N/A
	X Walk 1 Direction	To SW		X Walk 2 Direction	N/A
N/A	X Walk 1 Width (in)	N/A	N/A	X Walk 2 Width (in)	N/A
	X Walk 1 Slope (%)	1.1		X Walk 2 Slope (%)	N/A
	X Walk 1 X Slope (%)	3.8		X Walk 2 X Slope (%)	N/A

Remove & Replace Entire Ramp.
