Access Compliance Report

Public Rights-of-Way

(Curb Ramps)

Intersection ID: 14441	Main Street: E_KINGSTON_AV	Cross Street: SPRINGDALE_AV	Location: E
ADA ID: F51636C5CA78	Ramp Type: Perp	Initial Pass/Fail: Fail	Overall Compliance: No
Severity Score: 13.75			
Codes/Mitigation Info/Possible Solution		Field Measurements/Component Compliance

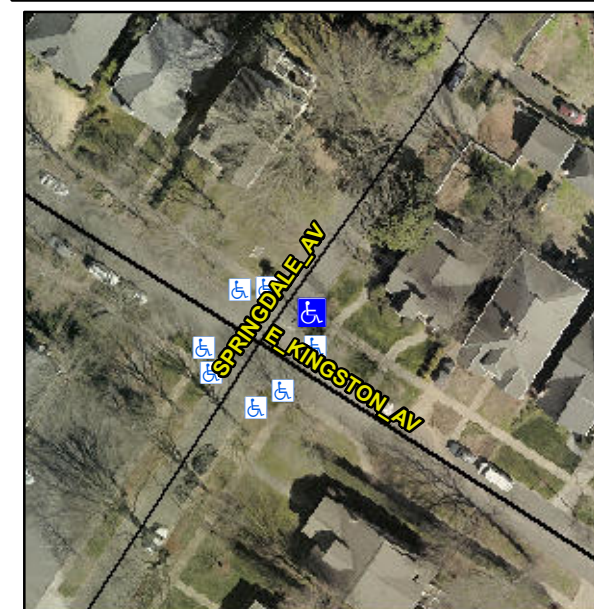
Not Found, R304.2.2, R304.5.3

Compliance	Description	Data	Compliance	Description	Data
N/A	Ramp Length (in)	67.0	No	Ramp Slope (%)	11.6
Yes	Ramp Width (in)	49.0	No	Ramp XSlope (%)	4.2
N/A	Flare Type LT	N/A	N/A	Flare Type RT	N/A
N/A	Flare Slope LT (%)	N/A	N/A	Flare Slope RT (%)	N/A
N/A	Flare Traversable LT?	N/A	N/A	Flare Traversable RT?	N/A
N/A	Landing Length (in)	N/A	N/A	DWS Provided?	N/A
N/A	Landing Width (in)	N/A	N/A	DWS Contrast?	N/A
N/A	Landing Slope (%)	N/A	N/A	DWS Length (in)	N/A
N/A	Landing X Slope (%)	N/A	N/A	DWS Full Width?	N/A
N/A	Landing Curb? (Y/N)	N/A	N/A	DWS Offset (in)	N/A
N/A	Shared Landing?	N/A			
N/A	Gutter Ponding?	N/A	N/A	Gutter Slope (%)	N/A
N/A	Gutter Lip Ht (in)	N/A	N/A	Gutter X Slope (%)	N/A
N/A	Painted X Walk1?	No	N/A	Painted X Walk2?	N/A
	X Walk 1 Direction	To NW		X Walk 2 Direction	N/A
N/A	X Walk 1 Width (in)	N/A	N/A	X Walk 2 Width (in)	N/A
	X Walk 1 Slope (%)	6.0		X Walk 2 Slope (%)	N/A
	X Walk 1 X Slope (%)	2.7		X Walk 2 X Slope (%)	N/A

N/A	Ramp inside XWalk1?	N/A	N/A	Ramp inside XWalk2?	N/A
	Road Slope (%)	N/A	N/A	Clear Space?	N/A
	Road X Slope (%)	N/A	N/A	Clear Space to XWalk (in)	N/A
N/A	Any Obstructions?	N/A	N/A	Storm Grate/Utility Hazard?	N/A
	Obstruction Type			Storm Grate/Utility Type	
		N/A			N/A
		Yes		Surface Condition? (G/P)	Good

Possible Solutions:

Remove & Replace Entire Ramp.

Total Cost: \$ 1850.00
