# Access Compliance Report

## Public Rights-of-Way

### (Curb Ramps)

| Intersection ID: 9082 | Main Street: BARRINGTON_DR | Cross Street: SOMERSWORTH_DR | Location: W |

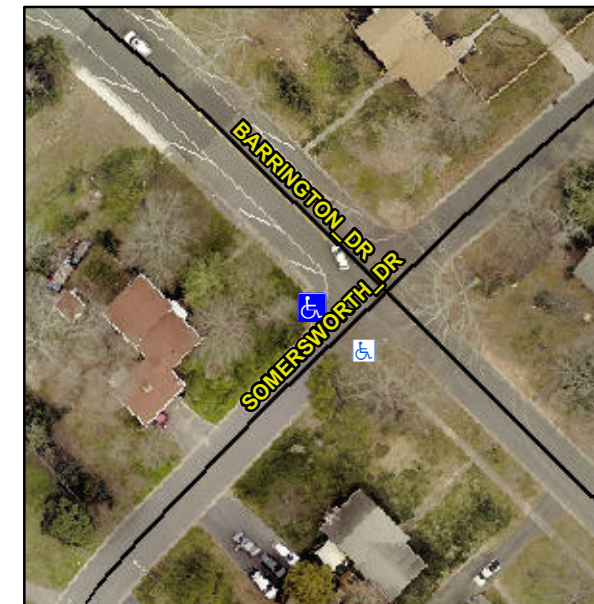
| ADA ID: F52776B4FCD9 | Ramp Type: Perp | Initial Pass/Fail: Fail | Overall Compliance: No |

**Not Found, R304.2.2, R304.5.3**

| Compliance | Description | Data | Compliance | Description | Data |
|---|---|---|---|---|---|
| N/A | Ramp Length (in) | 61.0 | No | Ramp Slope (%) | 9.2 |
| Yes | Ramp Width (in) | 48.0 | No | Ramp XSlope (%) | 6.6 |

Possible Solutions:

**Remove & Replace Entire Ramp.**

Total Cost: \$ 1850.00
