Access Compliance Report

Public Rights-of-Way

(Curb Ramps)

Intersection ID: N/A	Main Street: PROVIDENCE_COUNTRY_CLUB_DR	Cross Street: MCGILL_HEIGHTS_RD	Location: NE
ADA ID: F5345D095D12	Ramp Type: Directional	Initial Pass/Fail: Fail	Overall Compliance: No
			Severity Score: 25

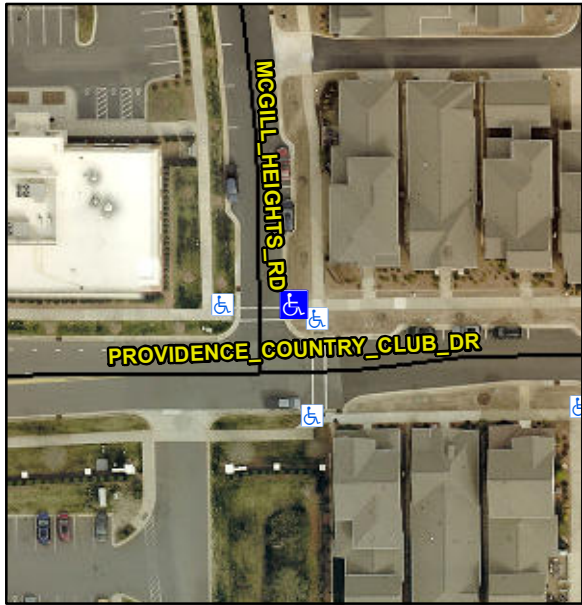
<p>Street 1 Name MCGILL HEIGHTS RD</p> <p>Stop Condition-Street 1 StopSign</p> <p>Street 2 Name N/A</p> <p>Stop Condition-Street 2 N/A</p>	Possible Solutions:		Compliance	Description	Data	Compliance	Description	Data
	Remove & Replace Entire Ramp.		N/A	Ramp Length (in)	81.0	N/A	Grade Break?	N/A
			Yes	Ramp Width (in)	69.0	N/A	Grade Break Slope (%)	0.0
			No	Ramp Slope (%)	9.5	N/A	Grade Break XSlope (%)	0.0
			No	Ramp XSlope (%)	5.8			
			N/A	Flare Type LT	N/A	N/A	Flare Type RT	N/A
			N/A	Flare Slope LT (%)	N/A	N/A	Flare Slope RT (%)	0.0
			N/A	Flare Traversable LT?	N/A	N/A	Flare Traversable RT?	N/A
			N/A	Landing Length (in)	0.0	N/A	DWS Provided?	N/A
			N/A	Landing Width (in)	0.0	N/A	DWS Contrast?	N/A
			N/A	Landing Slope (%)	0.0	N/A	DWS Length (in)	N/A
			N/A	Landing X Slope (%)	0.0	N/A	DWS Full Width?	N/A
			N/A	Landing Curb? (Y/N)	N/A	N/A	DWS Offset LT (in)	N/A

N/A	Shared Landing?	N/A	N/A	DWS Offset RT (in)	N/A
			N/A	Gutter Ponding?	0.0	N/A	Gutter Slope (%)	N/A
			N/A	Gutter Lip Ht (in)	1.0	N/A	Gutter X Slope (%)	N/A
			N/A	Painted X Walk1?	No		Road Slope (%)	1.0
				X Walk 1 Direction	To SW		Road X Slope (%)	2.6
				X Walk 1 Width (in)	N/A		Clear Space?	N/A
				X Walk 1 Slope (%)	1.0	N/A	Clear Space to XWalk (in)	N/A
				X Walk 1 X Slope (%)	2.6	N/A	Storm Grate/Utility Hazard?	N/A
			N/A	Ramp inside XWalk1?	N/A		Storm Grate/Utility Type	
			N/A	Any Obstructions?	N/A			N/A
				Obstruction Type		Yes	Surface Condition? (G/P)	Good
					N/A	N/A	Curb Slope (%)	13.6
Total Cost:		\$ 1600.00
