Access Compliance Report

Public Rights-of-Way

(Curb Ramps)

Intersection ID: 3101	Main Street: ALABASTER_CT	Cross Street: MINERAL_RIDGE_WY	Location:	N
ADA ID: F53A0E0FDB1C	Ramp Type: Perp	Initial Pass/Fail: Fail	Overall Compliance: No	Severity Score: 10
Codes/Mitigation Info/Possible Solution		Field Measurements/Component Compliance

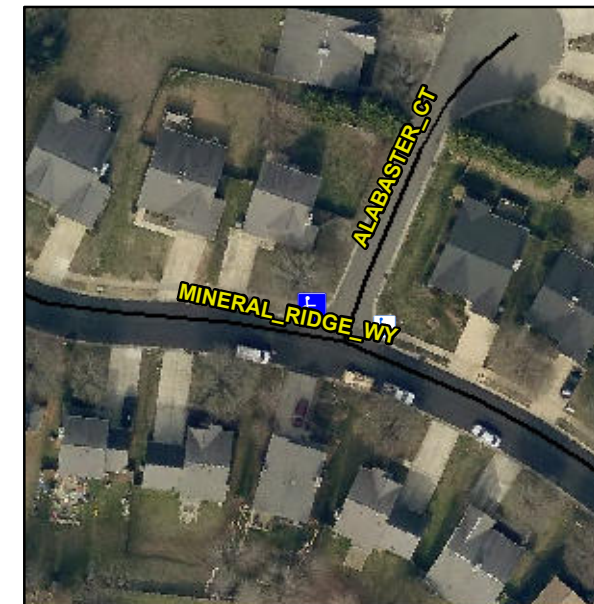
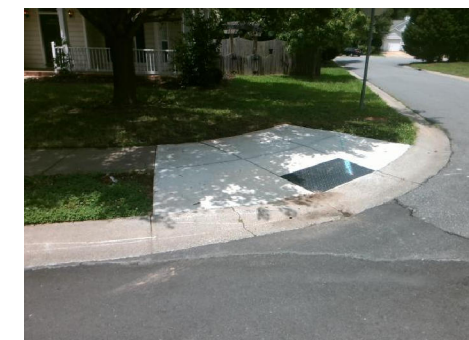
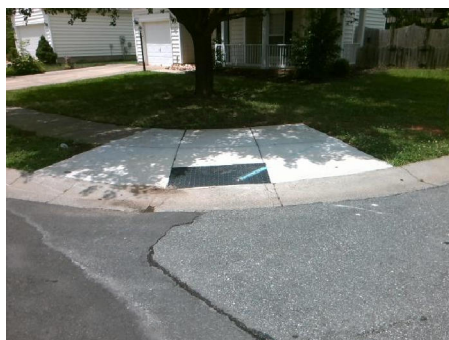
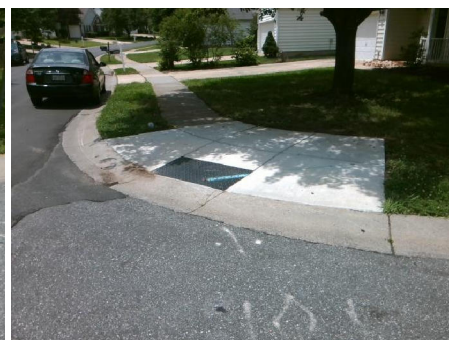
Not Found, R304.5.1, R304.5.3

Compliance	Description	Data	Compliance	Description	Data
N/A	Ramp Length (in)	51.0	Yes	Ramp Slope (%)	5.1
No	Ramp Width (in)	46.5	No	Ramp XSlope (%)	3.5
N/A	Flare Type LT	N/A	N/A	Flare Type RT	N/A
N/A	Flare Slope LT (%)	N/A	N/A	Flare Slope RT (%)	N/A
N/A	Flare Traversable LT?	N/A	N/A	Flare Traversable RT?	N/A
N/A	Landing Length (in)	N/A	N/A	DWS Provided?	N/A
N/A	Landing Width (in)	N/A	N/A	DWS Contrast?	N/A
N/A	Landing Slope (%)	N/A	N/A	DWS Length (in)	N/A
N/A	Landing X Slope (%)	N/A	N/A	DWS Full Width?	N/A
N/A	Landing Curb? (Y/N)	N/A	N/A	DWS Offset (in)	N/A
N/A	Shared Landing?	N/A			
N/A	Gutter Ponding?	N/A	N/A	Gutter Slope (%)	N/A
N/A	Gutter Lip Ht (in)	N/A	N/A	Gutter X Slope (%)	N/A
N/A	Painted X Walk1?	No	N/A	Painted X Walk2?	N/A
	X Walk 1 Direction	To SE		X Walk 2 Direction	N/A
N/A	X Walk 1 Width (in)	N/A	N/A	X Walk 2 Width (in)	N/A
	X Walk 1 Slope (%)	3.7		X Walk 2 Slope (%)	N/A
	X Walk 1 X Slope (%)	1.9		X Walk 2 X Slope (%)	N/A

N/A	Ramp inside XWalk1?	N/A	N/A	Ramp inside XWalk2?	N/A
	Road Slope (%)	N/A	N/A	Clear Space?	N/A
	Road X Slope (%)	N/A	N/A	Clear Space to XWalk (in)	N/A
N/A	Any Obstructions?	N/A	N/A	Storm Grate/Utility Hazard?	N/A
	Obstruction Type			Storm Grate/Utility Type	
		N/A			N/A
			Yes	Surface Condition? (G/P)	Good

Remove & Replace Entire Ramp.
