# Access Compliance Report

## Public Rights-of-Way

### (Curb Ramps)

Intersection ID: 5591	Main Street: CARVER_BV	Cross Street: HAWKINS_PL	Location: N
ADA ID: F545D303C83E	Ramp Type: Para	Initial Pass/Fail: Fail	Overall Compliance: No
			Severity Score: 31.25

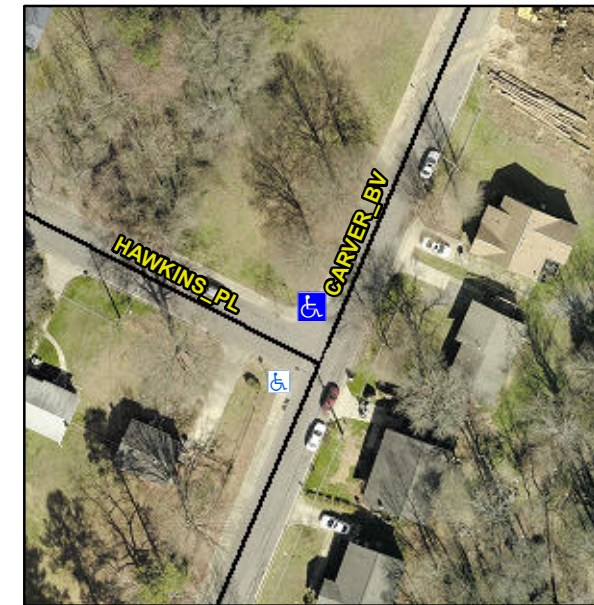
**RT RP < 5%**

**R304.5.1, R304.3.2, R304.5.3**

Compliance	Description	Data	Compliance	Description	Data
N/A	Ramp Length LT (in)	72.0	N/A	Ramp Length RT (in)	60.0
No	Ramp Width LT (in)	36.0	No	Ramp Width RT (in)	35.5
No	Ramp Slope LT (%)	11.6	Yes	Ramp Slope RT (%)	3.4
No	Ramp XSlope LT (%)	2.8	Yes	Ramp XSlope RT (%)	1.8
N/A	Landing Length (in)	N/A	N/A	DWS Provided?	N/A
N/A	Landing Width (in)	N/A	N/A	DWS Contrast?	N/A
N/A	Landing Slope (%)	N/A	N/A	DWS Length (in)	N/A
N/A	Landing X Slope (%)	N/A	N/A	DWS Full Width?	N/A
N/A	Landing Curb? (Y/N)	N/A	N/A	DWS Offset (in)	N/A
N/A	Shared Landing?	N/A			
N/A	Gutter Ponding?	N/A	N/A	Gutter Slope (%)	N/A
N/A	Gutter Lip Ht (in)	N/A	N/A	Gutter X Slope (%)	N/A
N/A	Painted X Walk1?	No	N/A	Painted X Walk2?	N/A
	X Walk 1 Direction	To SW		X Walk 2 Direction	N/A
N/A	X Walk 1 Width (in)	N/A	N/A	X Walk 2 Width (in)	N/A
	X Walk 1 Slope (%)	1.5		X Walk 2 Slope (%)	N/A
	X Walk 1 X Slope (%)	3.2		X Walk 2 X Slope (%)	N/A
N/A	Ramp inside XWalk1?	N/A	N/A	Ramp inside XWalk2?	N/A

Road Slope (%)	N/A	N/A	Clear Space?	N/A
	Road X Slope (%)	N/A	N/A	Clear Space to XWalk (in)	N/A
N/A	Any Obstructions?	N/A	N/A	Storm Grate/Utility Hazard?	N/A
	Obstruction Type			Storm Grate/Utility Type	
		N/A			N/A
			Yes	Surface Condition? (G/P)	Good
			N/A	Curb Slope (%)	15.7

**Remove & Replace Entire Ramp.**

Total Cost: \$ 1600.00
