Access Compliance Report

Public Rights-of-Way

(Curb Ramps)

Intersection ID: 10779	Main Street: AVIDXCHANGE_LN	Cross Street: HAMILTON_ST	Location: SE
ADA ID: F54912AF03A6	Ramp Type: Perp	Initial Pass/Fail: Fail	Overall Compliance: No
Severity Score: 22.5			
Codes/Mitigation Info/Possible Solution		Field Measurements/Component Compliance

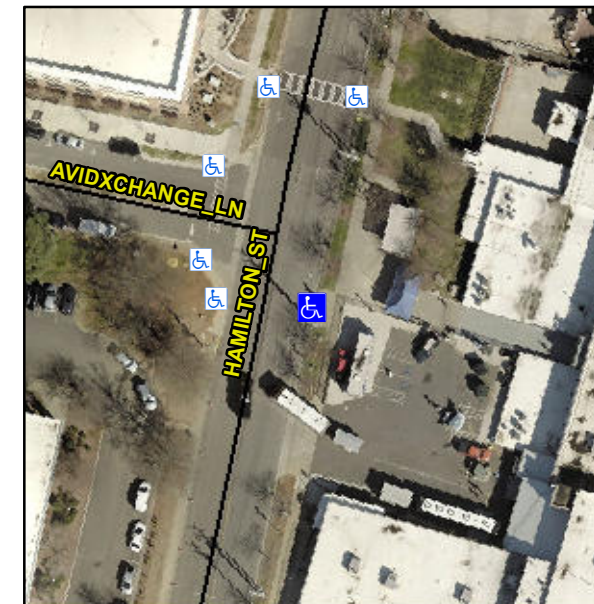
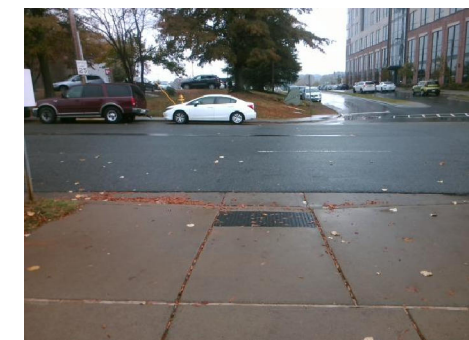
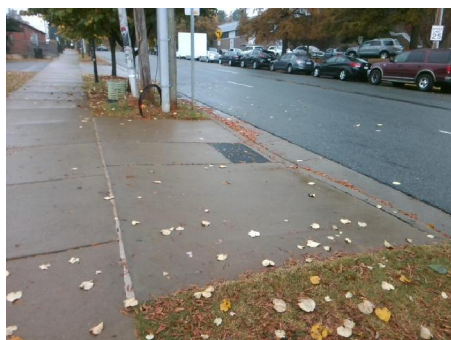
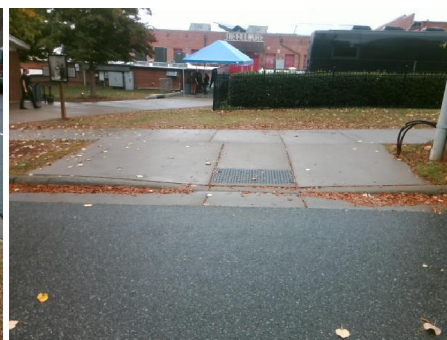
Not Found, R304.5.1, R304.2.2

Compliance	Description	Data	Compliance	Description	Data
N/A	Ramp Length (in)	94.5	No	Ramp Slope (%)	8.4
No	Ramp Width (in)	47.0	Yes	Ramp XSlope (%)	4.3
N/A	Flare Type LT	N/A	N/A	Flare Type RT	N/A
N/A	Flare Slope LT (%)	N/A	N/A	Flare Slope RT (%)	N/A
N/A	Flare Traversable LT?	N/A	N/A	Flare Traversable RT?	N/A
N/A	Landing Length (in)	N/A	N/A	DWS Provided?	N/A
N/A	Landing Width (in)	N/A	N/A	DWS Contrast?	N/A
N/A	Landing Slope (%)	N/A	N/A	DWS Length (in)	N/A
N/A	Landing X Slope (%)	N/A	N/A	DWS Full Width?	N/A
N/A	Landing Curb? (Y/N)	N/A	N/A	DWS Offset (in)	N/A
N/A	Shared Landing?	N/A			
N/A	Gutter Ponding?	N/A	N/A	Gutter Slope (%)	N/A
N/A	Gutter Lip Ht (in)	N/A	N/A	Gutter X Slope (%)	N/A
N/A	Painted X Walk1?	No	N/A	Painted X Walk2?	N/A
	X Walk 1 Direction	To W		X Walk 2 Direction	N/A
N/A	X Walk 1 Width (in)	N/A	N/A	X Walk 2 Width (in)	N/A
	X Walk 1 Slope (%)	3.1		X Walk 2 Slope (%)	N/A
	X Walk 1 X Slope (%)	4.7		X Walk 2 X Slope (%)	N/A

N/A	Ramp inside XWalk1?	N/A	N/A	Ramp inside XWalk2?	N/A
	Road Slope (%)	N/A	N/A	Clear Space?	N/A
	Road X Slope (%)	N/A	N/A	Clear Space to XWalk (in)	N/A
N/A	Any Obstructions?	N/A	N/A	Storm Grate/Utility Hazard?	N/A
	Obstruction Type			Storm Grate/Utility Type	
		N/A			N/A
			Yes	Surface Condition? (G/P)	Good

Remove & Replace Entire Ramp.

Total Cost: \$ 1850.00
