# Access Compliance Report

## Public Rights-of-Way

### (Curb Ramps)

Intersection ID: 5672	Main Street: SUNSET_RD	Cross Street: BEATTIES_FORD_RD	Location: SE
ADA ID: F54A9952E1AB	Ramp Type: Perp	Initial Pass/Fail: Fail	Overall Compliance: No
Severity Score: 13.75			
Codes/Mitigation Info/Possible Solution		Field Measurements/Component Compliance

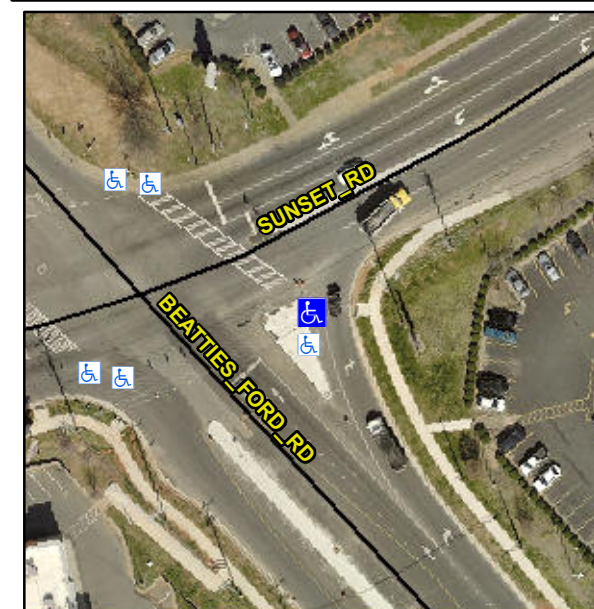
**Not Found, R304.2.2, R304.5.3**

Compliance	Description	Data	Compliance	Description	Data
N/A	Ramp Length (in)	60.0	No	Ramp Slope (%)	8.4
Yes	Ramp Width (in)	48.0	No	Ramp XSlope (%)	2.6
N/A	Flare Type LT	N/A	N/A	Flare Type RT	N/A
N/A	Flare Slope LT (%)	N/A	N/A	Flare Slope RT (%)	N/A
N/A	Flare Traversable LT?	N/A	N/A	Flare Traversable RT?	N/A
N/A	Landing Length (in)	N/A	N/A	DWS Provided?	N/A
N/A	Landing Width (in)	N/A	N/A	DWS Contrast?	N/A
N/A	Landing Slope (%)	N/A	N/A	DWS Length (in)	N/A
N/A	Landing X Slope (%)	N/A	N/A	DWS Full Width?	N/A
N/A	Landing Curb? (Y/N)	N/A	N/A	DWS Offset (in)	N/A
N/A	Shared Landing?	N/A			
N/A	Gutter Ponding?	N/A	N/A	Gutter Slope (%)	N/A
N/A	Gutter Lip Ht (in)	N/A	N/A	Gutter X Slope (%)	N/A
N/A	Painted X Walk1?	No	N/A	Painted X Walk2?	N/A
	X Walk 1 Direction	To NW		X Walk 2 Direction	N/A
N/A	X Walk 1 Width (in)	N/A	N/A	X Walk 2 Width (in)	N/A
	X Walk 1 Slope (%)	0.1		X Walk 2 Slope (%)	N/A
	X Walk 1 X Slope (%)	0.2		X Walk 2 X Slope (%)	N/A

N/A	Ramp inside XWalk1?	N/A	N/A	Ramp inside XWalk2?	N/A
	Road Slope (%)	N/A	N/A	Clear Space?	N/A
	Road X Slope (%)	N/A	N/A	Clear Space to XWalk (in)	N/A
N/A	Any Obstructions?	N/A	N/A	Storm Grate/Utility Hazard?	N/A
	Obstruction Type			Storm Grate/Utility Type	
		N/A			N/A
			Yes	Surface Condition? (G/P)	Good

**Remove & Replace Entire Ramp.**

Total Cost: \$ 1850.00
