Access Compliance Report

Public Rights-of-Way

(Curb Ramps)

Intersection ID: N/A	Main Street: BACROFT_ST	Cross Street: NORRIS_AV	Location: E
ADA ID: F55932D71D3A	Ramp Type: Combination2Diag	Initial Pass/Fail: Fail	Overall Compliance: No
		Severity Score: 0

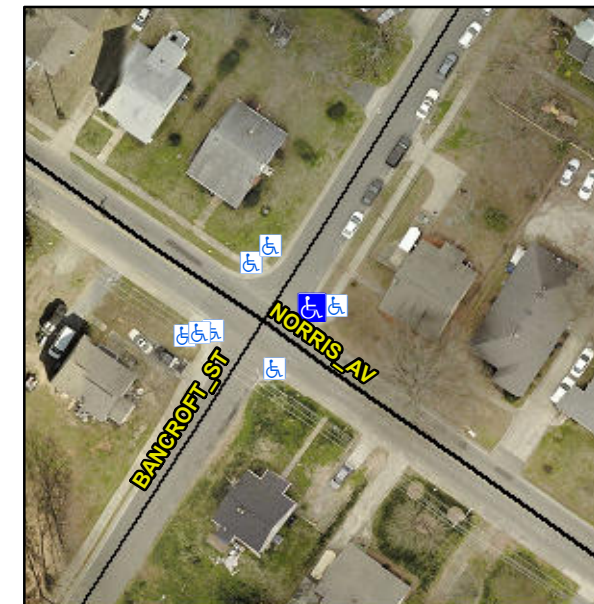
Not Found, R304.5.1, R304.5.3

Compliance	Description	Data	Compliance	Description	Data
N/A	Ramp Length LT (in)	25.0	N/A	Ramp Length RT (in)	33.5
Yes	Ramp Width LT (in)	58.5	Yes	Ramp Width RT (in)	59.5
Yes	Ramp Slope LT (%)	6.6	Yes	Ramp Slope RT (%)	1.7
No	Ramp XSlope LT (%)	2.8	Yes	Ramp XSlope RT (%)	1.9
N/A	Ramp Length (in)	61.5	Yes	Ramp Slope (%)	8.3
No	Ramp Width (in)	47.0	No	Ramp XSlope (%)	2.6
N/A	Flare Type LT	N/A	N/A	Flare Type RT	N/A
N/A	Flare Slope LT (%)	N/A	N/A	Flare Slope RT (%)	N/A
N/A	Flare Traversable LT?	N/A	N/A	Flare Traversable RT?	N/A
N/A	Landing Length (in)	N/A	N/A	DWS Provided?	N/A
N/A	Landing Width (in)	N/A	N/A	DWS Contrast?	N/A
N/A	Landing Slope (%)	N/A	N/A	DWS Length (in)	N/A
N/A	Landing X Slope (%)	N/A	N/A	DWS Full Width?	N/A
N/A	Landing Curb? (Y/N)	N/A	N/A	DWS Offset (in)	N/A
N/A	Shared Landing?	N/A			
N/A	Gutter Ponding?	N/A	N/A	Gutter Slope (%)	N/A
N/A	Gutter Lip Ht (in)	N/A	N/A	Gutter X Slope (%)	N/A
N/A	Painted X Walk1?	No	N/A	Painted X Walk2?	No

X Walk 1 Direction	To NW		X Walk 2 Direction	To SW
	X Walk 1 Width (in)	N/A		X Walk 2 Width (in)	N/A
	X Walk 1 Slope (%)	1.3		X Walk 2 Slope (%)	0.9
	X Walk 1 X Slope (%)	0.9		X Walk 2 X Slope (%)	2.8
N/A	Ramp inside XWalk1?	N/A	N/A	Ramp inside XWalk2?	N/A
	Road Slope (%)	1.3		Clear Space?	N/A
	Road X Slope (%)	2.3	N/A	Clear Space to XWalk (in)	N/A
			N/A	Any Obstruction?	N/A
				Obstruction Type	N/A
			N/A	Storm Grate/Utility Hazard?	N/A
				Storm Grate/Utility Type	N/A
Yes	Surface Condition? (G/P)	Good			
	Curb Slope (%)	9.8

Remove & Replace Curb Ramp With Two New Directional Ramps or Equivalent.
