Access Compliance Report

Public Rights-of-Way

(Curb Ramps)

Intersection ID: N/A	Main Street: E MARTIN LUTHER KING JR BV	Cross Street: S CALDWELL ST	Location: E
ADA ID: F55CE8CA15B7	Ramp Type: PerpDiag	Initial Pass/Fail: Fail	Overall Compliance: No
Severity Score: 33.75			
Codes/Mitigation Info/Possible Solution		Field Measurements/Component Compliance

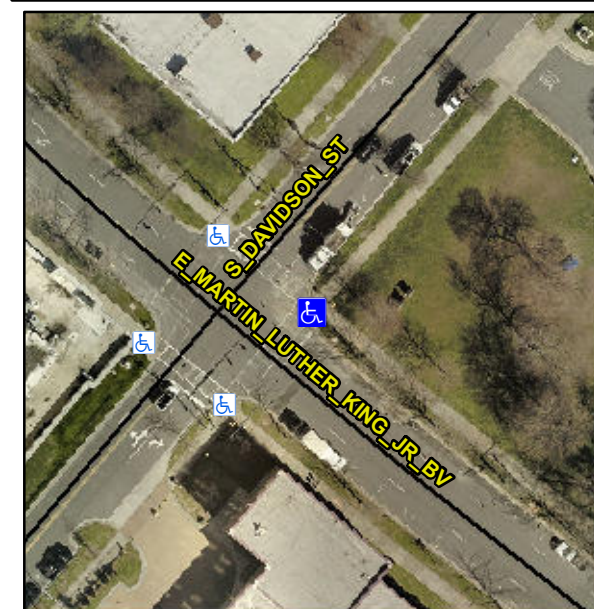
Not Found, R304.5.1, R304.2.2

Compliance	Description	Data	Compliance	Description	Data
N/A	Ramp Length (in)	102.0	No	Ramp Slope (%)	12.1
No	Ramp Width (in)	39.0	Yes	Ramp XSlope (%)	1.3
N/A	Flare Type LT	N/A	N/A	Flare Type RT	N/A
N/A	Flare Slope LT (%)	N/A	N/A	Flare Slope RT (%)	N/A
N/A	Flare Traversable LT?	No	N/A	Flare Traversable RT?	No
N/A	Landing Length (in)	N/A	N/A	DWS Provided?	N/A
N/A	Landing Width (in)	N/A	N/A	DWS Contrast?	N/A
N/A	Landing Slope (%)	N/A	N/A	DWS Length (in)	N/A
N/A	Landing X Slope (%)	N/A	N/A	DWS Full Width?	N/A
N/A	Landing Curb? (Y/N)	N/A	N/A	DWS Offset (in)	N/A
N/A	Shared Landing?	N/A			
N/A	Gutter Ponding?	N/A	N/A	Gutter Slope (%)	N/A
N/A	Gutter Lip Ht (in)	N/A	N/A	Gutter X Slope (%)	N/A
N/A	Painted X Walk1?	Yes	N/A	Painted X Walk2?	Yes
	X Walk 1 Direction	To NW		X Walk 2 Direction	To SW
N/A	X Walk 1 Width (in)	110.0	N/A	X Walk 2 Width (in)	115.5
	X Walk 1 Slope (%)	0.9		X Walk 2 Slope (%)	0.8
	X Walk 1 X Slope (%)	0.4		X Walk 2 X Slope (%)	3.2

N/A	Ramp inside XWalk1?	Yes	N/A	Ramp inside XWalk2?	Yes
	Road Slope (%)	0.1	N/A	Clear Space?	N/A
	Road X Slope (%)	1.7	N/A	Clear Space to XWalk (in)	N/A
N/A	Any Obstructions?	N/A	N/A	Storm Grate/Utility Hazard?	N/A
	Obstruction Type			Storm Grate/Utility Type	
		N/A			N/A
		Yes		Surface Condition? (G/P)	Good

Remove & Replace Curb Ramp With Two New Directional Ramps or Equivalent.
