Access Compliance Report

Public Rights-of-Way

(Curb Ramps)

Intersection ID: 4726	Main Street: FARINGFORD_CT	Cross Street: HENSLOWE_LN	Location: W
ADA ID: F5945650C722	Ramp Type: Directional1	Initial Pass/Fail: Fail	Overall Compliance: No
			Severity Score: 21.25

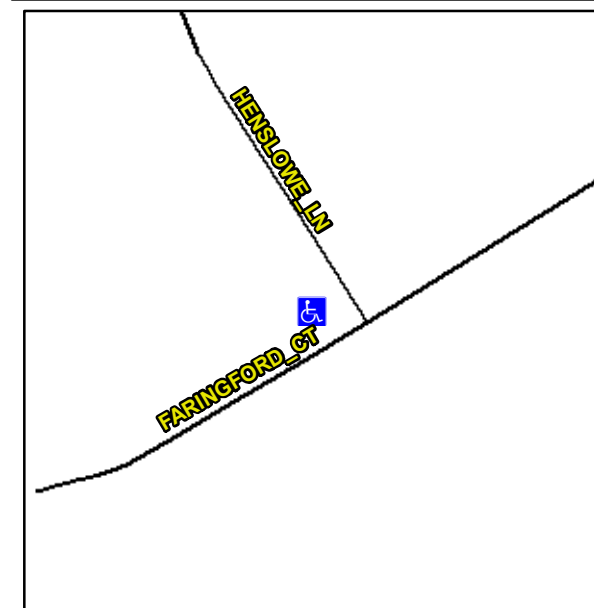
Compliance	Description	Data	Compliance	Description	Data
N/A	Ramp Length (in)	67.0	N/A	Grade Break?	N/A
No	Ramp Width (in)	47.0	N/A	Grade Break Slope (%)	0.0
No	Ramp Slope (%)	8.6	N/A	Grade Break XSlope (%)	0.0
Yes	Ramp XSlope (%)	1.7			
N/A	Flare Type LT	N/A	N/A	Flare Type RT	N/A
N/A	Flare Slope LT (%)	N/A	N/A	Flare Slope RT (%)	0.0
N/A	Flare Traversable LT?	N/A	N/A	Flare Traversable RT?	N/A
N/A	Landing Length (in)	0.0	N/A	DWS Provided?	N/A
N/A	Landing Width (in)	0.0	N/A	DWS Contrast?	N/A
N/A	Landing Slope (%)	0.0	N/A	DWS Length (in)	N/A
N/A	Landing X Slope (%)	0.0	N/A	DWS Full Width?	N/A
N/A	Landing Curb? (Y/N)	N/A	N/A	DWS Offset LT (in)	N/A
N/A	Shared Landing?	N/A	N/A	DWS Offset RT (in)	N/A
N/A	Gutter Ponding?	0.0	N/A	Gutter Slope (%)	N/A
N/A	Gutter Lip Ht (in)	0.0	N/A	Gutter X Slope (%)	N/A
N/A	Painted X Walk1?	No		Road Slope (%)	4.3
	X Walk 1 Direction	To E		Road X Slope (%)	2.1
	X Walk 1 Width (in)	N/A		Clear Space?	N/A

X Walk 1 Slope (%)	4.3	N/A	Clear Space to XWalk (in)	N/A
	X Walk 1 X Slope (%)	2.1	N/A	Storm Grate/Utility Hazard?	N/A
N/A	Ramp inside XWalk1?	N/A		Storm Grate/Utility Type	
N/A	Any Obstructions?	N/A			N/A
	Obstruction Type		Yes	Surface Condition? (G/P)	Good
			N/A	Curb Slope (%)	9.4

Possible Solutions:

Remove & Replace Entire Ramp.
