## Access Compliance Report Public Rights-of-Way (Curb Ramps)

Intersection ID: 48087Main Street:RED\_CREST\_LNCross Street:MALLARD\_GLEN\_DRLocation:NWADA ID: F5963D52A8B5Ramp Type:PerpInitial Pass/Fail:FailOverall Compliance:NoSeverity Score:21.25

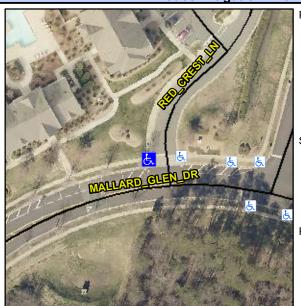
No
N/A
N/A
N/A
Surveyor Notes:
N/A
N/A
N/A
N/A
N/A
N/A
PROW/ADA:
R304.5.1, R304.2.2
N/A
N/A

Occupling a Description Date Occupling Description Description					
Compliance Description		Data		oliance Description	Data
N/A	Ramp Length (in)	62.0	No	Ramp Slope (%)	9.4
No	Ramp Width (in)	46.0	Yes	Ramp XSlope (%)	0.9
N/A	Flare Type LT	N/A	N/A	Flare Type RT	N/A
N/A	Flare Slope LT (%)	N/A	N/A	Flare Slope RT (%)	N/A
N/A	Flare Traversable LT?	N/A	N/A	Flare Traversable RT?	N/A
N/A	Landing Length (in)	N/A	N/A	DWS Provided?	N/A
N/A	Landing Width (in)	N/A	N/A	DWS Contrast?	N/A
N/A	Landing Slope (%)	N/A	N/A	DWS Length (in)	N/A
N/A	Landing X Slope (%)	N/A	N/A	DWS Full Width?	N/A
N/A	Landing Curb? (Y/N)	N/A	N/A	DWS Offset (in)	N/A
N/A	Shared Landing?	N/A			
N/A	Gutter Ponding?	N/A	N/A	Gutter Slope (%)	N/A
N/A	Gutter Lip Ht (in)	N/A	N/A	Gutter X Slope (%)	N/A
N/A	Painted X Walk1?	No	N/A	Painted X Walk2?	N/A
	X Walk 1 Direction	To E		X Walk 2 Direction	N/A
N/A	X Walk 1 Width (in)	N/A	N/A	X Walk 2 Width (in)	N/A
	X Walk 1 Slope (%)	1.0		X Walk 2 Slope (%)	N/A

Remove & Replace Entire Ramp.
