Access Compliance Report

Public Rights-of-Way

(Curb Ramps)

Intersection ID: 48987	Main Street: ASHTON_GATE_DR	Cross Street: SMITHFIELD_DR	Location: SW
ADA ID: F596DC8E896E	Ramp Type: Perp	Initial Pass/Fail: Fail	Overall Compliance: No
Codes/Mitigation Info/Possible Solution		Field Measurements/Component Compliance	
Severity Score: 22.5

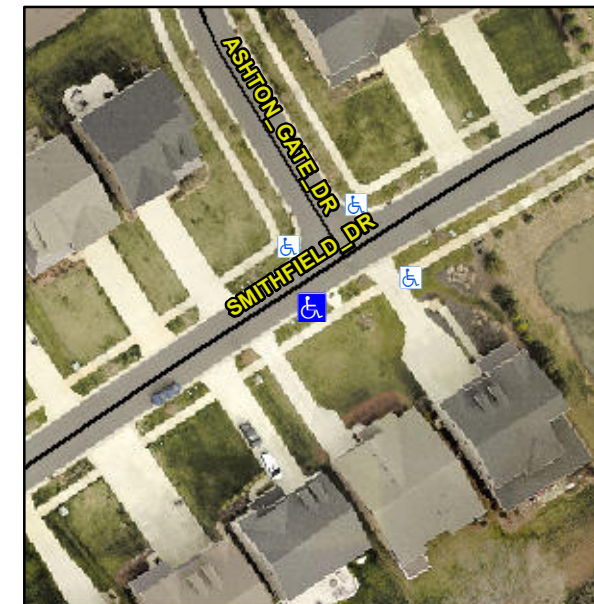
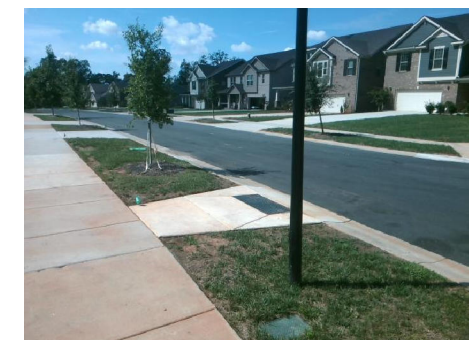
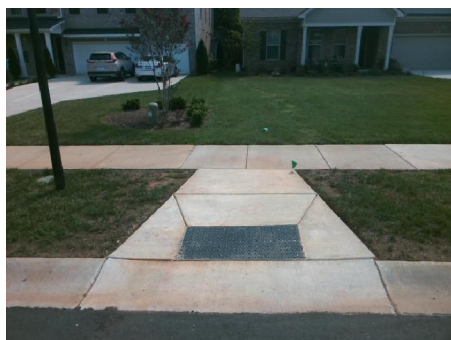
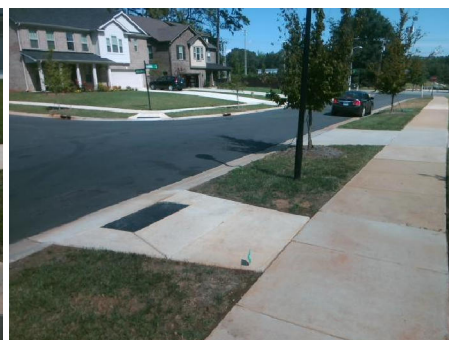
Not Found, R304.5.1, R304.2.2, R304.5.3

Compliance	Description	Data	Compliance	Description	Data
N/A	Ramp Length (in)	56.0	No	Ramp Slope (%)	8.5
No	Ramp Width (in)	47.5	No	Ramp XSlope (%)	3.5
N/A	Flare Type LT	N/A	N/A	Flare Type RT	N/A
N/A	Flare Slope LT (%)	N/A	N/A	Flare Slope RT (%)	N/A
N/A	Flare Traversable LT?	N/A	N/A	Flare Traversable RT?	N/A
N/A	Landing Length (in)	N/A	N/A	DWS Provided?	N/A
N/A	Landing Width (in)	N/A	N/A	DWS Contrast?	N/A
N/A	Landing Slope (%)	N/A	N/A	DWS Length (in)	N/A
N/A	Landing X Slope (%)	N/A	N/A	DWS Full Width?	N/A
N/A	Landing Curb? (Y/N)	N/A	N/A	DWS Offset (in)	N/A
N/A	Shared Landing?	N/A			
N/A	Gutter Ponding?	N/A	N/A	Gutter Slope (%)	N/A
N/A	Gutter Lip Ht (in)	N/A	N/A	Gutter X Slope (%)	N/A
N/A	Painted X Walk1?	No	N/A	Painted X Walk2?	N/A
	X Walk 1 Direction	To NW		X Walk 2 Direction	N/A
N/A	X Walk 1 Width (in)	N/A	N/A	X Walk 2 Width (in)	N/A
	X Walk 1 Slope (%)	4.8		X Walk 2 Slope (%)	N/A
	X Walk 1 X Slope (%)	1.8		X Walk 2 X Slope (%)	N/A

N/A	Ramp inside XWalk1?	N/A	N/A	Ramp inside XWalk2?	N/A
	Road Slope (%)	N/A	N/A	Clear Space?	N/A
	Road X Slope (%)	N/A	N/A	Clear Space to XWalk (in)	N/A
N/A	Any Obstructions?	N/A	N/A	Storm Grate/Utility Hazard?	N/A
	Obstruction Type			Storm Grate/Utility Type	
		N/A			N/A
			Yes	Surface Condition? (G/P)	Good

Remove & Replace Entire Ramp.
