Access Compliance Report Public Rights-of-Way (Curb Ramps)

Intersection ID: 8350 Main Street: LASALLE ST **Cross Street: CUSTER_ST** Location: NE ADA ID: F599C3C370D2 Ramp Type: PerpDiag Initial Pass/Fail: Fail **Overall Compliance: No Severity Score:** 35

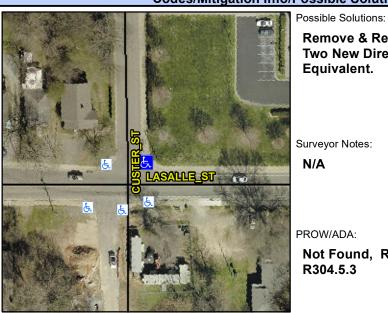
Field Measurements/Component Compliance								
	Comp	liance Description	Data	Comp	oliance Description	Data		
	N/A	Ramp Length (in)	59.5	No	Ramp Slope (%)	12.3		
	No	Ramp Width (in)	39.0	No	Ramp XSlope (%)	3.4		
	N/A	Flare Type LT	N/A	N/A	Flare Type RT	N/A		
	N/A	Flare Slope LT (%)	N/A	N/A	Flare Slope RT (%)	N/A		
	N/A	Flare Traversable LT?	N/A	N/A	Flare Traversable RT?	N/A		
	N/A	Landing Length (in)	N/A	N/A	DWS Provided?	N/A		
	N/A	Landing Width (in)	N/A	N/A	DWS Contrast?	N/A		
	N/A	Landing Slope (%)	N/A	N/A	DWS Length (in)	N/A		
	N/A	Landing X Slope (%)	N/A	N/A	DWS Full Width?	N/A		
	N/A	Landing Curb? (Y/N)	N/A	N/A	DWS Offset (in)	N/A		
	N/A	Shared Landing?	N/A					
	N/A	Gutter Ponding?	N/A	N/A	Gutter Slope (%)	N/A		
	N/A	Gutter Lip Ht (in)	N/A	N/A	Gutter X Slope (%)	N/A		
	N/A	Painted X Walk1?	No	N/A	Painted X Walk2?	No		
		X Walk 1 Direction	To W		X Walk 2 Direction	To S		
	N/A	X Walk 1 Width (in)	N/A	N/A	X Walk 2 Width (in)	N/A

X Walk 1 Slope (%)	1.6		X Walk 2 Slope (%)	1.4		
		X Walk 1 X Slope (%)	3.7		X Walk 2 X Slope (%)	1.2		
	N/A	Ramp inside XWalk1?	N/A	N/A	Ramp inside XWalk2?	N/A		
		Road Slope (%)	1.6	N/A	Clear Space?	N/A		
		Road X Slope (%)	0.7	N/A	Clear Space to XWalk (in)	N/A		
	N/A	Any Obstructions?	N/A	N/A	Storm Grate/Utility Hazard?	N/A		
		Obstruction Type			Storm Grate/Utility Type			
			N/A			N/A		
				Yes	Surface Condition? (G/P)	Good

CUSTER ST Street 1 Name Stop Condition-Street 2 StopSign **LASALLE ST** Street 2 Name Stop Condition-Street 1 None Remove & Replace Curb Ramp With Two New Directional Ramps or Equivalent.

N/A
				N/A
Surveyor Notes:				N/A
N/A				N/A
				N/A
				N/A
				N/A
PROW/ADA:				N/A
Not Found,	R304.5.1, R304.	2.2,		N/A
R304.5.3				N/A
				N/A
				N/A
T.1.0		_		N/A
Total Cost:	•	\$	3200.00
