Access Compliance Report

Public Rights-of-Way

(Curb Ramps)

Intersection ID: 10861	Main Street: STATESVILLE_AV	Cross Street: DALTON_AV	Location: NE
ADA ID: F5A261F3ACEE	Ramp Type: PerpDiag	Initial Pass/Fail: Fail	Overall Compliance: No
		Severity Score: 10

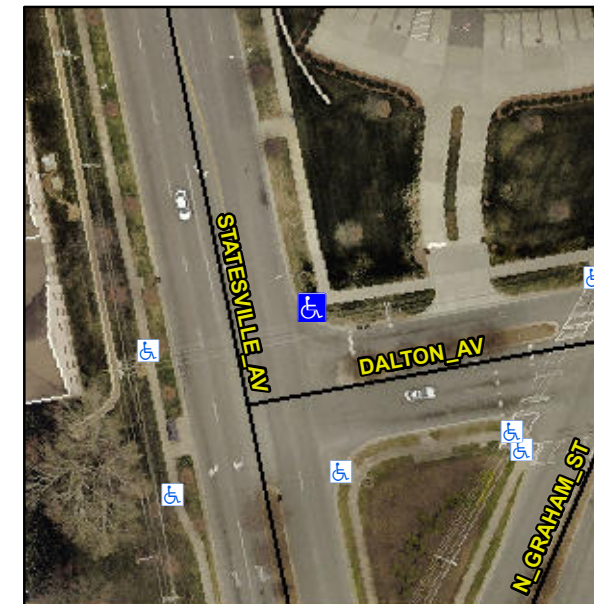
Not Found, R304.5.1, R304.5.3

Compliance	Description	Data	Compliance	Description	Data
N/A	Ramp Length (in)	85.5	Yes	Ramp Slope (%)	7.2
No	Ramp Width (in)	47.5	No	Ramp XSlope (%)	2.4
N/A	Flare Type LT	N/A	N/A	Flare Type RT	N/A
N/A	Flare Slope LT (%)	N/A	N/A	Flare Slope RT (%)	N/A
N/A	Flare Traversable LT?	N/A	N/A	Flare Traversable RT?	N/A
N/A	Landing Length (in)	N/A	N/A	DWS Provided?	N/A
N/A	Landing Width (in)	N/A	N/A	DWS Contrast?	N/A
N/A	Landing Slope (%)	N/A	N/A	DWS Length (in)	N/A
N/A	Landing X Slope (%)	N/A	N/A	DWS Full Width?	N/A
N/A	Landing Curb? (Y/N)	N/A	N/A	DWS Offset (in)	N/A
N/A	Shared Landing?	N/A			
N/A	Gutter Ponding?	N/A	N/A	Gutter Slope (%)	N/A
N/A	Gutter Lip Ht (in)	N/A	N/A	Gutter X Slope (%)	N/A
N/A	Painted X Walk1?	No	N/A	Painted X Walk2?	No
	X Walk 1 Direction	To W		X Walk 2 Direction	To S
N/A	X Walk 1 Width (in)	N/A	N/A	X Walk 2 Width (in)	N/A
	X Walk 1 Slope (%)	3.9		X Walk 2 Slope (%)	0.9
	X Walk 1 X Slope (%)	1.6		X Walk 2 X Slope (%)	1.0

N/A	Ramp inside XWalk1?	N/A	N/A	Ramp inside XWalk2?	N/A
	Road Slope (%)	0.6	N/A	Clear Space?	N/A
	Road X Slope (%)	0.1	N/A	Clear Space to XWalk (in)	N/A
N/A	Any Obstructions?	N/A	N/A	Storm Grate/Utility Hazard?	N/A
	Obstruction Type			Storm Grate/Utility Type	
		N/A			N/A
			Yes	Surface Condition? (G/P)	Good

Remove & Replace Curb Ramp With Two New Directional Ramps or Equivalent.
