Access Compliance Report

Public Rights-of-Way

(Curb Ramps)

Intersection ID: 48946	Main Street: DAVID_JENNINGS_AV	Cross Street: MITCHELL_GRANT_WY	Location: N
ADA ID: F5A641E52C17	Ramp Type: Combination1	Initial Pass/Fail: Fail	Overall Compliance: No
		Severity Score: 33.75

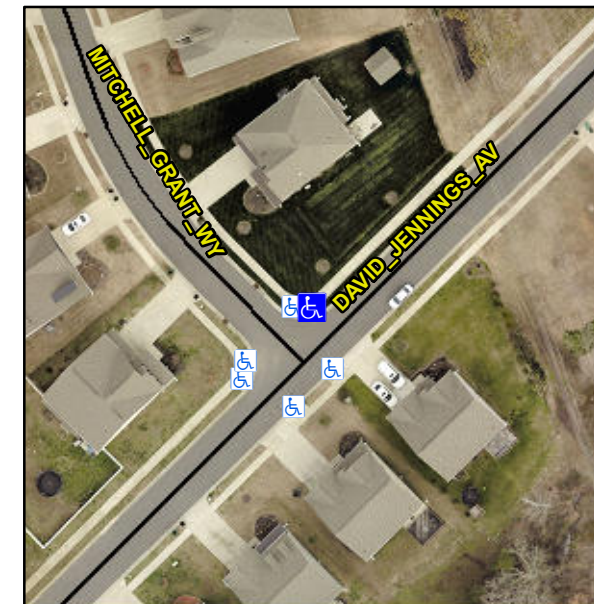
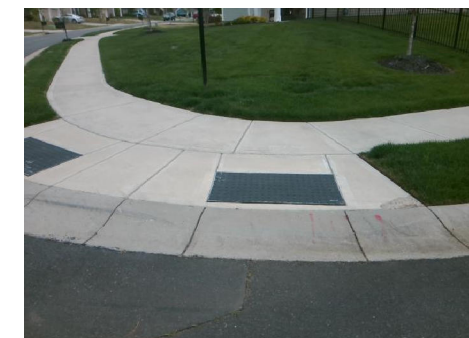
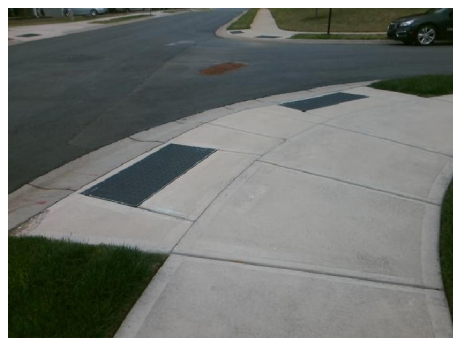
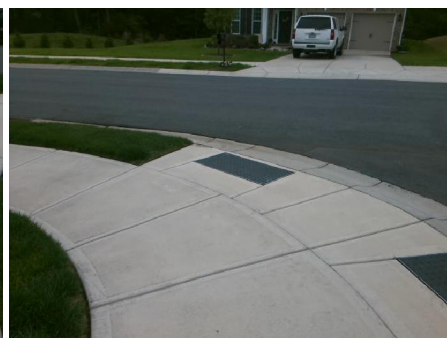
Not Found, R304.5.1, R304.5.3

Compliance	Description	Data	Compliance	Description	Data
N/A	Ramp Length LT (in)	16.0	N/A	Ramp Length RT (in)	2.0
Yes	Ramp Width LT (in)	60.5	Yes	Ramp Width RT (in)	59.5
Yes	Ramp Slope LT (%)	7.6	Yes	Ramp Slope RT (%)	6.3
Yes	Ramp XSlope LT (%)	0.3	Yes	Ramp XSlope RT (%)	1.2
N/A	Ramp Length (in)	47.0	Yes	Ramp Slope (%)	5.3
No	Ramp Width (in)	47.0	No	Ramp XSlope (%)	7.2
N/A	Flare Type LT	N/A	N/A	Flare Type RT	N/A
N/A	Flare Slope LT (%)	N/A	N/A	Flare Slope RT (%)	N/A
N/A	Flare Traversable LT?	N/A	N/A	Flare Traversable RT?	N/A
N/A	Landing Length (in)	N/A	N/A	DWS Provided?	N/A
N/A	Landing Width (in)	N/A	N/A	DWS Contrast?	N/A
N/A	Landing Slope (%)	N/A	N/A	DWS Length (in)	N/A
N/A	Landing X Slope (%)	N/A	N/A	DWS Full Width?	N/A
N/A	Landing Curb? (Y/N)	N/A	N/A	DWS Offset (in)	N/A
N/A	Shared Landing?	N/A			
N/A	Gutter Ponding?	N/A	N/A	Gutter Slope (%)	N/A
N/A	Gutter Lip Ht (in)	N/A	N/A	Gutter X Slope (%)	N/A
N/A	Painted X Walk1?	No	N/A	Painted X Walk2?	N/A

X Walk 1 Direction	To SE		X Walk 2 Direction	N/A
	X Walk 1 Width (in)	N/A		X Walk 2 Width (in)	N/A
	X Walk 1 Slope (%)	2.5		X Walk 2 Slope (%)	N/A
	X Walk 1 X Slope (%)	2.1		X Walk 2 X Slope (%)	N/A
N/A	Ramp inside XWalk1?	N/A	N/A	Ramp inside XWalk2?	N/A
	Road Slope (%)	N/A		Clear Space?	N/A
	Road X Slope (%)	N/A	N/A	Clear Space to XWalk (in)	N/A
			N/A	Any Obstruction?	N/A
				Obstruction Type	N/A
			N/A	Storm Grate/Utility Hazard?	N/A
				Storm Grate/Utility Type	N/A
			Yes	Surface Condition? (G/P)	Good
				Curb Slope (%)	17.7

Remove & Replace Entire Ramp.
