# Access Compliance Report

## Public Rights-of-Way

### (Curb Ramps)

| Intersection ID: 43676 | Main Street: SARDIS_COMMONS_LN | Cross Street: SARDIS_RD | Location: E |

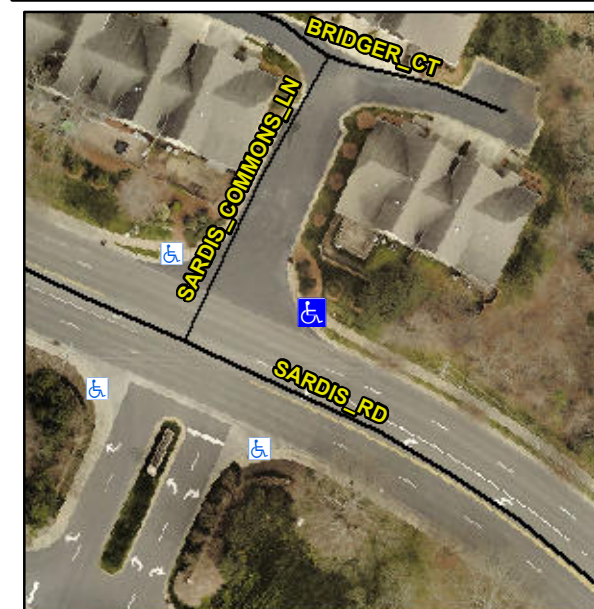
**Not Found, R304.5.1, R304.2.2, R304.5.3**

| Compliance | Description | Data | Compliance | Description | Data |
|---|---|---|---|---|---|
| N/A | Ramp Length (in) | 47.5 | No | Ramp Slope (%) | 8.4 |
| No | Ramp Width (in) | 43.0 | No | Ramp XSlope (%) | 7.2 |

**Remove & Replace Curb Ramp With Two New Directional Ramps or Equivalent.**
