Access Compliance Report

Public Rights-of-Way

(Curb Ramps)

| Intersection ID: 9838 | Main Street: AINTREE_RD | Cross Street: THE_PLAZA | Location: SW |

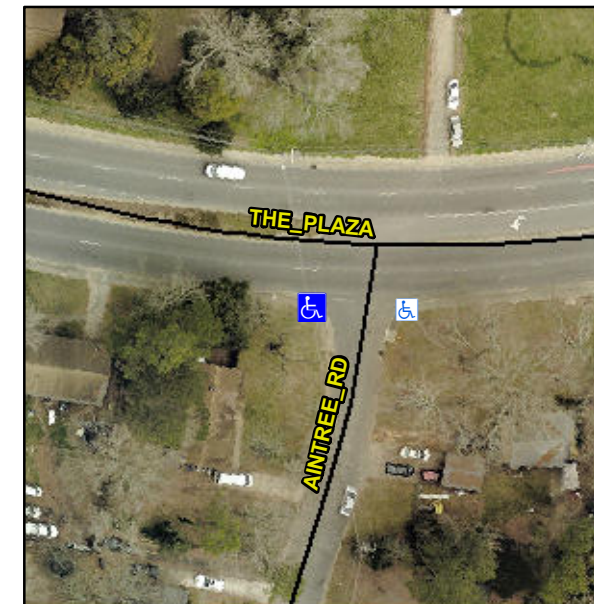
| ADA ID: F5BA89750B90 | Ramp Type: Perp | Initial Pass/Fail: Fail | Overall Compliance: No |
| | | Severity Score: 12.5 | |

Not Found, R304.2.2

| Compliance | Description | Data | Compliance | Description | Data |
|---|---|---|---|---|---|
| N/A | Ramp Length (in) | 61.5 | No | Ramp Slope (%) | 11.0 |

Remove & Replace Entire Ramp.
