Access Compliance Report

Public Rights-of-Way

(Curb Ramps)

Intersection ID: 10955	Main Street: ROBINSON_CHURCH_RD	Cross Street: CASTLE_GARDEN_LN	Location: N
ADA ID: F5C7A0995D78	Ramp Type: Perp	Initial Pass/Fail: Fail	Overall Compliance: No
Severity Score: 21.25			
Codes/Mitigation Info/Possible Solution		Field Measurements/Component Compliance

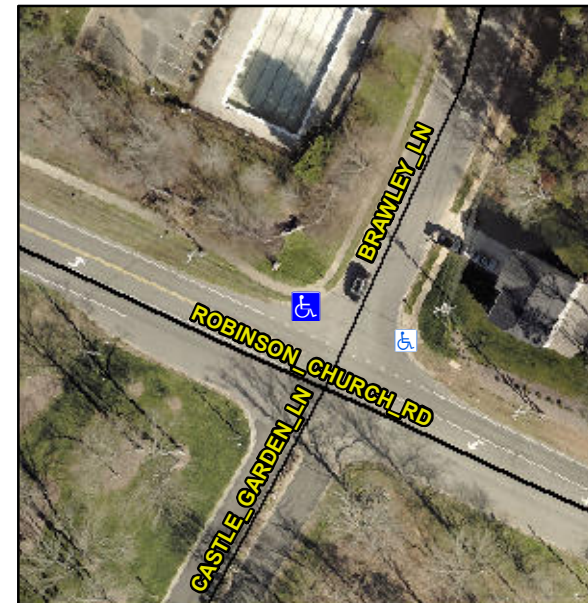
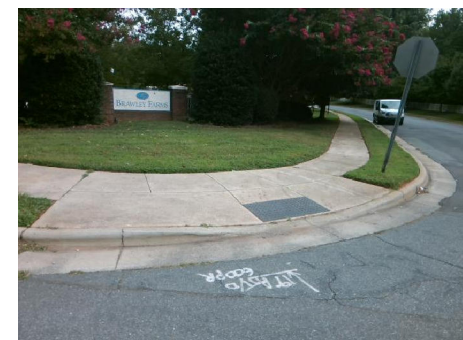
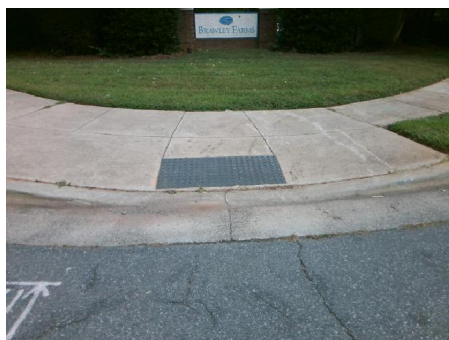
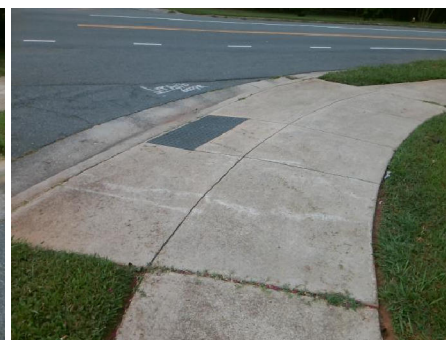
Not Found, R304.5.1, R304.2.2

Compliance	Description	Data	Compliance	Description	Data
N/A	Ramp Length (in)	48.0	No	Ramp Slope (%)	10.1
No	Ramp Width (in)	43.5	Yes	Ramp XSlope (%)	0.6
N/A	Flare Type LT	N/A	N/A	Flare Type RT	N/A
N/A	Flare Slope LT (%)	N/A	N/A	Flare Slope RT (%)	N/A
N/A	Flare Traversable LT?	N/A	N/A	Flare Traversable RT?	N/A
N/A	Landing Length (in)	N/A	N/A	DWS Provided?	N/A
N/A	Landing Width (in)	N/A	N/A	DWS Contrast?	N/A
N/A	Landing Slope (%)	N/A	N/A	DWS Length (in)	N/A
N/A	Landing X Slope (%)	N/A	N/A	DWS Full Width?	N/A
N/A	Landing Curb? (Y/N)	N/A	N/A	DWS Offset (in)	N/A
N/A	Shared Landing?	N/A			
N/A	Gutter Ponding?	N/A	N/A	Gutter Slope (%)	N/A
N/A	Gutter Lip Ht (in)	N/A	N/A	Gutter X Slope (%)	N/A
N/A	Painted X Walk1?	No	N/A	Painted X Walk2?	N/A
	X Walk 1 Direction	To SE		X Walk 2 Direction	N/A
N/A	X Walk 1 Width (in)	N/A	N/A	X Walk 2 Width (in)	N/A
	X Walk 1 Slope (%)	2.9		X Walk 2 Slope (%)	N/A
	X Walk 1 X Slope (%)	2.8		X Walk 2 X Slope (%)	N/A

N/A	Ramp inside XWalk1?	N/A	N/A	Ramp inside XWalk2?	N/A
	Road Slope (%)	N/A	N/A	Clear Space?	N/A
	Road X Slope (%)	N/A	N/A	Clear Space to XWalk (in)	N/A
N/A	Any Obstructions?	N/A	N/A	Storm Grate/Utility Hazard?	N/A
	Obstruction Type			Storm Grate/Utility Type	
		N/A			N/A
			Yes	Surface Condition? (G/P)	Good

Remove & Replace Entire Ramp.
