Access Compliance Report

Public Rights-of-Way

(Curb Ramps)

Intersection ID: 7593	Main Street: BANNISTER_PL	Cross Street: YUMA_ST	Location: NW
ADA ID: F5EF1BE2759B	Ramp Type: Perp	Initial Pass/Fail: Fail	Overall Compliance: No
Severity Score: 22.5			
Codes/Mitigation Info/Possible Solution		Field Measurements/Component Compliance

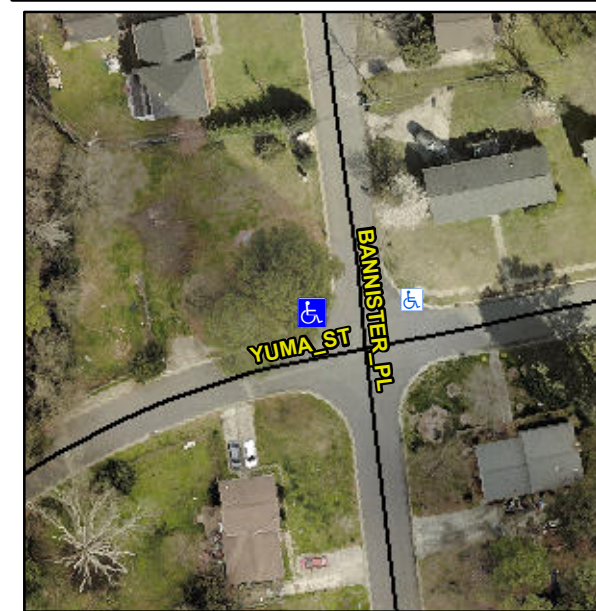
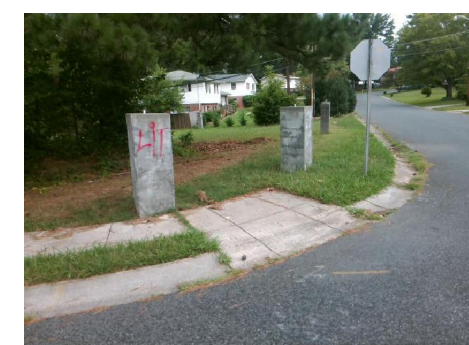
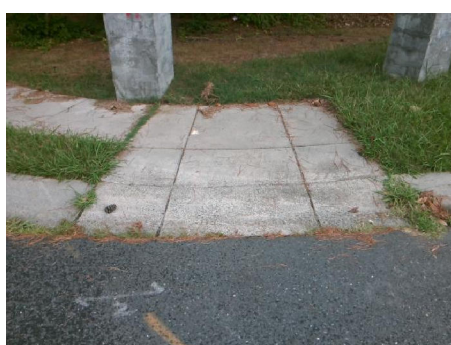
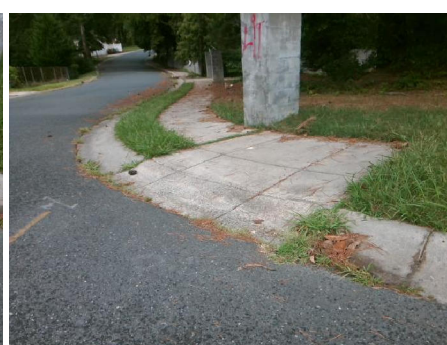
Not Found, R304.5.1, R304.2.2, R304.5.3

Compliance	Description	Data	Compliance	Description	Data
N/A	Ramp Length (in)	24.0	No	Ramp Slope (%)	8.8
No	Ramp Width (in)	42.0	No	Ramp XSlope (%)	3.6
N/A	Flare Type LT	N/A	N/A	Flare Type RT	N/A
N/A	Flare Slope LT (%)	N/A	N/A	Flare Slope RT (%)	N/A
N/A	Flare Traversable LT?	N/A	N/A	Flare Traversable RT?	N/A
N/A	Landing Length (in)	N/A	N/A	DWS Provided?	N/A
N/A	Landing Width (in)	N/A	N/A	DWS Contrast?	N/A
N/A	Landing Slope (%)	N/A	N/A	DWS Length (in)	N/A
N/A	Landing X Slope (%)	N/A	N/A	DWS Full Width?	N/A
N/A	Landing Curb? (Y/N)	N/A	N/A	DWS Offset (in)	N/A
N/A	Shared Landing?	N/A			
N/A	Gutter Ponding?	N/A	N/A	Gutter Slope (%)	N/A
N/A	Gutter Lip Ht (in)	0.75	N/A	Gutter X Slope (%)	N/A
N/A	Painted X Walk1?	No	N/A	Painted X Walk2?	N/A
	X Walk 1 Direction	To E		X Walk 2 Direction	N/A
N/A	X Walk 1 Width (in)	N/A	N/A	X Walk 2 Width (in)	N/A
	X Walk 1 Slope (%)	8.0		X Walk 2 Slope (%)	N/A
	X Walk 1 X Slope (%)	0.6		X Walk 2 X Slope (%)	N/A

N/A	Ramp inside XWalk1?	N/A	N/A	Ramp inside XWalk2?	N/A
	Road Slope (%)	N/A	N/A	Clear Space?	N/A
	Road X Slope (%)	N/A	N/A	Clear Space to XWalk (in)	N/A
N/A	Any Obstructions?	N/A	N/A	Storm Grate/Utility Hazard?	N/A
	Obstruction Type			Storm Grate/Utility Type	
		N/A			N/A
			Yes	Surface Condition? (G/P)	Good

Remove & Replace Entire Ramp.

Total Cost: \$ 1850.00
