Access Compliance Report

Public Rights-of-Way

(Curb Ramps)

Intersection ID: N/A	Main Street: PROVIDENCE_RD	Cross Street: N/A	Location: NW
ADA ID: F5F75FC29F61	Ramp Type: PerpDiag	Initial Pass/Fail: Fail	Overall Compliance: No
Severity Score: 46.25			
Codes/Mitigation Info/Possible Solution		Field Measurements/Component Compliance

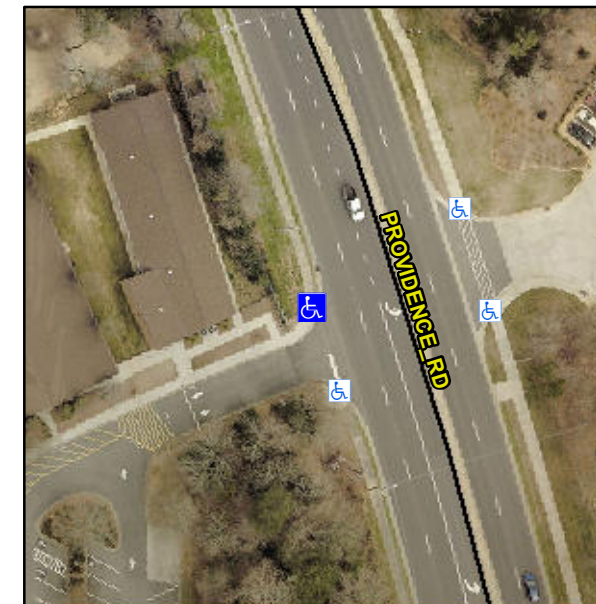
Not Found, R304.5.1, R304.2.2, R304.5.3

Compliance	Description	Data	Compliance	Description	Data
N/A	Ramp Length (in)	72.0	No	Ramp Slope (%)	8.8
No	Ramp Width (in)	39.0	No	Ramp XSlope (%)	8.4
N/A	Flare Type LT	N/A	N/A	Flare Type RT	N/A
N/A	Flare Slope LT (%)	N/A	N/A	Flare Slope RT (%)	N/A
N/A	Flare Traversable LT?	N/A	N/A	Flare Traversable RT?	N/A
N/A	Landing Length (in)	N/A	N/A	DWS Provided?	N/A
N/A	Landing Width (in)	N/A	N/A	DWS Contrast?	N/A
N/A	Landing Slope (%)	N/A	N/A	DWS Length (in)	N/A
N/A	Landing X Slope (%)	N/A	N/A	DWS Full Width?	N/A
N/A	Landing Curb? (Y/N)	N/A	N/A	DWS Offset (in)	N/A
N/A	Shared Landing?	N/A			
N/A	Gutter Ponding?	N/A	N/A	Gutter Slope (%)	N/A
N/A	Gutter Lip Ht (in)	N/A	N/A	Gutter X Slope (%)	N/A
N/A	Painted X Walk1?	No	N/A	Painted X Walk2?	No
	X Walk 1 Direction	To S		X Walk 2 Direction	To E
N/A	X Walk 1 Width (in)	N/A	N/A	X Walk 2 Width (in)	N/A
	X Walk 1 Slope (%)	1.1		X Walk 2 Slope (%)	11.5
	X Walk 1 X Slope (%)	9.0		X Walk 2 X Slope (%)	2.6

N/A	Ramp inside XWalk1?	N/A	N/A	Ramp inside XWalk2?	N/A
	Road Slope (%)	6.3	N/A	Clear Space?	N/A
	Road X Slope (%)	8.1	N/A	Clear Space to XWalk (in)	N/A
N/A	Any Obstructions?	N/A	N/A	Storm Grate/Utility Hazard?	N/A
	Obstruction Type			Storm Grate/Utility Type	
		N/A			N/A
			Yes	Surface Condition? (G/P)	Good

Remove & Replace Curb Ramp With Two New Directional Ramps or Equivalent.
