Access Compliance Report

Public Rights-of-Way

(Curb Ramps)

Intersection ID: 29416	Main Street: PADDARBORN_CT	Cross Street: SALINGER_WY	Location: W
ADA ID: F5FAFE36E595	Ramp Type: Perp	Initial Pass/Fail: Fail	Overall Compliance: No
Severity Score: 13.75			
Codes/Mitigation Info/Possible Solution		Field Measurements/Component Compliance

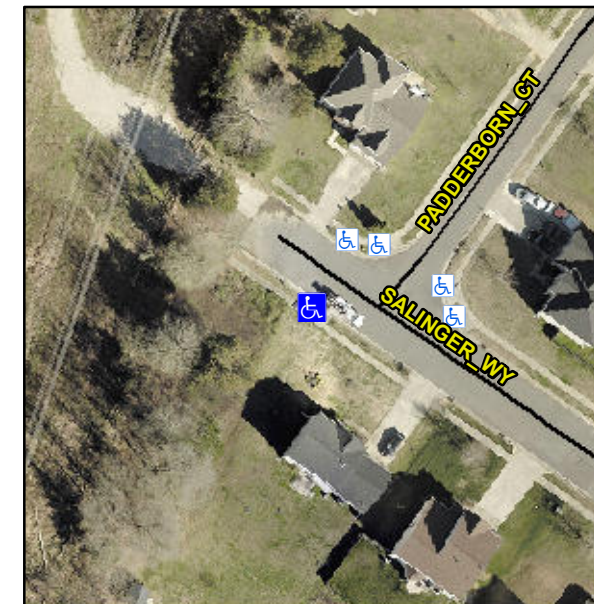
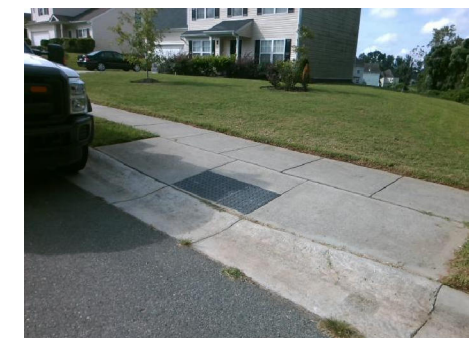
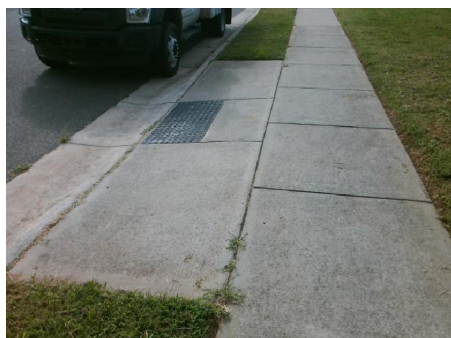
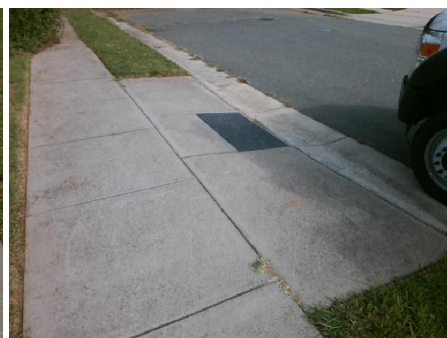
Not Found, R304.2.2, R304.5.3

Compliance	Description	Data	Compliance	Description	Data
N/A	Ramp Length (in)	49.5	No	Ramp Slope (%)	11.9
Yes	Ramp Width (in)	48.0	No	Ramp XSlope (%)	3.5
N/A	Flare Type LT	N/A	N/A	Flare Type RT	N/A
N/A	Flare Slope LT (%)	N/A	N/A	Flare Slope RT (%)	N/A
N/A	Flare Traversable LT?	N/A	N/A	Flare Traversable RT?	N/A
N/A	Landing Length (in)	N/A	N/A	DWS Provided?	N/A
N/A	Landing Width (in)	N/A	N/A	DWS Contrast?	N/A
N/A	Landing Slope (%)	N/A	N/A	DWS Length (in)	N/A
N/A	Landing X Slope (%)	N/A	N/A	DWS Full Width?	N/A
N/A	Landing Curb? (Y/N)	N/A	N/A	DWS Offset (in)	N/A
N/A	Shared Landing?	N/A			
N/A	Gutter Ponding?	N/A	N/A	Gutter Slope (%)	N/A
N/A	Gutter Lip Ht (in)	N/A	N/A	Gutter X Slope (%)	N/A
N/A	Painted X Walk1?	No	N/A	Painted X Walk2?	N/A
	X Walk 1 Direction	To NE		X Walk 2 Direction	N/A
N/A	X Walk 1 Width (in)	N/A	N/A	X Walk 2 Width (in)	N/A
	X Walk 1 Slope (%)	3.3		X Walk 2 Slope (%)	N/A
	X Walk 1 X Slope (%)	2.1		X Walk 2 X Slope (%)	N/A

N/A	Ramp inside XWalk1?	N/A	N/A	Ramp inside XWalk2?	N/A
	Road Slope (%)	N/A	N/A	Clear Space?	N/A
	Road X Slope (%)	N/A	N/A	Clear Space to XWalk (in)	N/A
N/A	Any Obstructions?	N/A	N/A	Storm Grate/Utility Hazard?	N/A
	Obstruction Type			Storm Grate/Utility Type	
		N/A			N/A
			Yes	Surface Condition? (G/P)	Good

Possible Solutions:

Remove & Replace Entire Ramp.
