## Access Compliance Report Public Rights-of-Way (Curb Ramps)

Intersection ID: 49927	Main Str	reet: ASHBOURNE_HALL_RD	Cross Street: CAMPBELL_HALL_CT				Location:	NE
ADA ID: F624A9D705B8		ype: Perp	Initial Pass/Fail: Fail Overall Compliance: No			o Severity Score:	13.75	
Codes/Mitigation Info/Possible Solution			Field Measurements/Component Compliance					
Possible Solutions:						liance Description	Data	
	2 MANY NY	Remove & Replace Entire Ramp.	N/A	Ramp Length (in)	48.0		Ramp Slope (%)	8.8

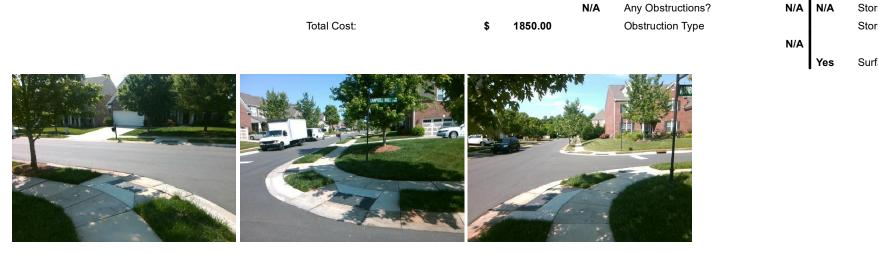
E.	ist the	Remove & Replace Entire Ramp.	Yes	Ramp Width (in)		No	Ramp XSlope (%)	5.0
	and the second		N/A	Flare Type LT		N/A	Flare Type RT	N/A
		1	N/A	Flare Slope LT (%)		N/A	Flare Slope RT (%)	N/A
			N/A	Flare Traversable LT?	N/A	N/A	Flare Traversable RT?	N/A
	1/2		N/A	Landing Length (in)	N/A	N/A	DWS Provided?	N/A
	A State	Surveyor Notes:	N/A	Landing Width (in)	N/A	N/A	DWS Contrast?	N/A
the subscription of the su	The OF A	N/A	N/A	Landing Slope (%)	N/A	N/A	DWS Length (in)	N/A
& Although	Carl Star	174	N/A	Landing X Slope (%)	N/A	N/A	DWS Full Width?	N/A
A A A A A A A A A A A A A A A A A A A			N/A	Landing Curb? (Y/N)	N/A	N/A	DWS Offset (in)	N/A
Gran de			N/A	Shared Landing?	N/A			
		PROW/ADA:	N/A	Gutter Ponding?	N/A	N/A	Gutter Slope (%)	N/A
		R304.2.2, R304.5.3	N/A	Gutter Lip Ht (in)	N/A	N/A	Gutter X Slope (%)	N/A
	14 A	R304.2.2, R304.5.5	N/A	Painted X Walk1?	No	N/A	Painted X Walk2?	N/A
	1 0 x			X Walk 1 Direction	To SE	10/4	X Walk 2 Direction	N/A

6 N 1 1 1		N/A	X Walk 1 Width (in)	N/A	N/A	X Walk 2 Width (in)	N/A
Street 1 Name CAMPBELL HALL CT			17/8	X Walk 1 Slope (%)	1.6	17/2	X Walk 2 Slope (%)	N/A
Stop Condition-Street 2	None			X Walk 1 X Slope (%)	3.4		X Walk 2 X Slope (%)	N/A
Street 2 Name	None N/A		N/A	Ramp inside XWalk1?	-	N/A	Ramp inside XWalk2?	N/A
	N/A N/A		N/A	•	N/A N/A	N/A	•	N/A N/A
Stop Condition-Street 1	N/A			Road Slope (%)	N/A N/A	N/A	Clear Space?	N/A N/A
			<b>N1/A</b>	Road X Slope (%)			Clear Space to XWalk (in)	
		Tatal Cast:	N/A	Any Obstructions?	N/A	N/A	Storm Grate/Utility Hazard?	N/A
		Total Cost: \$ 1	850.00	Obstruction Type	N// A		Storm Grate/Utility Type	N1/A
					N/A			N/A
