Access Compliance Report

Public Rights-of-Way

(Curb Ramps)

Intersection ID: 27315	Main Street: ELM_LN	Cross Street: BALLANTYNE_TRACE_CT	Location: SW
ADA ID: F625AE7A453B	Ramp Type: BlendTrans2	Initial Pass/Fail: Fail	Overall Compliance: No
Severity Score: 10			
Codes/Mitigation Info/Possible Solution		Field Measurements/Component Compliance

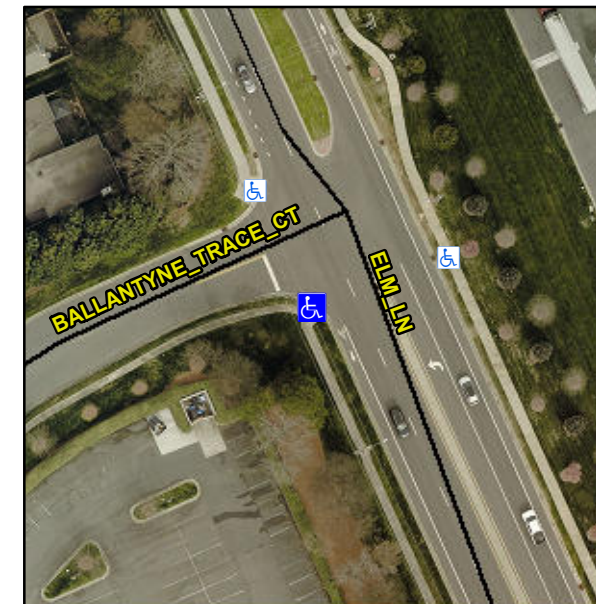
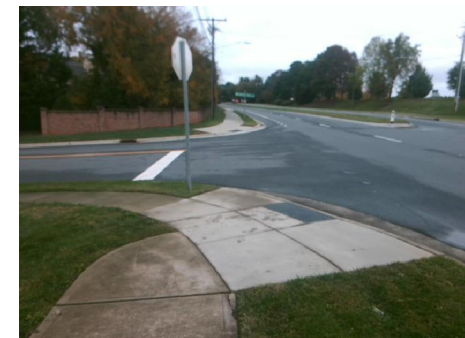
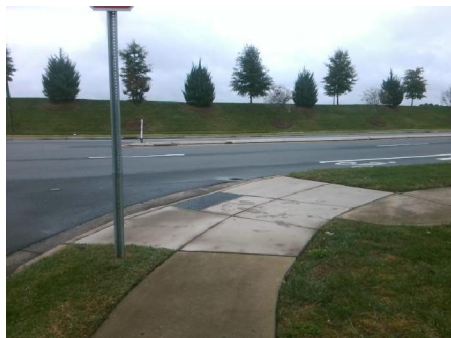
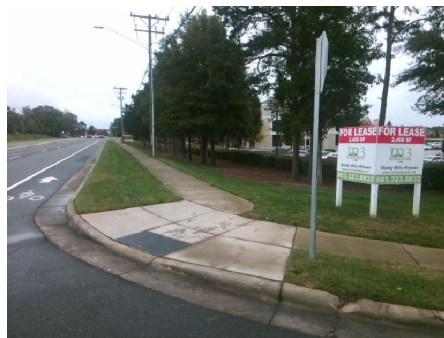
Not Found, R304.5.1, R304.5.3

Compliance	Description	Data	Compliance	Description	Data
N/A	Ramp Length (in)	97.0	Yes	BlendTrans Slope (%)	4.2
No	Ramp Width (in)	43.5	No	BlendTrans XSlope (%)	2.9
N/A	Flare Type LT	N/A	N/A	Flare Type RT	N/A
N/A	Flare Slope LT (%)	N/A	N/A	Flare Slope RT (%)	N/A
N/A	Flare Traversable LT?	N/A	N/A	Flare Traversable RT?	N/A
N/A	Landing Length (in)	N/A	N/A	DWS Provided?	N/A
N/A	Landing Width (in)	N/A	N/A	DWS Contrast?	N/A
N/A	Landing Slope (%)	N/A	N/A	DWS Length (in)	N/A
N/A	Landing X Slope (%)	N/A	N/A	DWS Full Width?	N/A
N/A	Landing Curb? (Y/N)	N/A	N/A	DWS Offset (in)	N/A
N/A	Shared Landing?	N/A			
N/A	Gutter Ponding?	N/A	N/A	Gutter Slope (%)	N/A
N/A	Gutter Lip Ht (in)	N/A	N/A	Gutter X Slope (%)	N/A
N/A	Painted X Walk1?	No	N/A	Painted X Walk2?	No
	X Walk 1 Direction	To NE		X Walk 2 Direction	To NW
	X Walk 1 Width (in)	N/A		X Walk 2 Width (in)	N/A
	X Walk 1 Slope (%)	0.8		X Walk 2 Slope (%)	1.8
	X Walk 1 X Slope (%)	0.5		X Walk 2 X Slope (%)	5.0

N/A	Ramp inside XWalk1?	N/A	N/A	Ramp inside XWalk2?	N/A
	Road Slope (%)	3.7		Clear Space?	N/A
	Road X Slope (%)	0.7	N/A	Clear Space to XWalk (in)	N/A
N/A	Any Obstructions?	N/A	N/A	Storm Grate/Utility Hazard?	N/A
	Obstruction Type			Storm Grate/Utility Type	
		N/A			N/A
			Yes	Surface Condition? (G/P)	Good
			No	Curb Slope (%)	22.4

Remove & Replace Curb Ramp With Two New Directional Ramps or Equivalent.
