## **Access Compliance Report Public Rights-of-Way** (Curb Ramps)

Intersection ID: 24705 Main Street: CHOATE CR Cross Street: CINNAMON\_FIELD\_RD Location: SW **Severity Score:** ADA ID: F62A2C43EC5A Ramp Type: Perp Initial Pass/Fail: Fail **Overall Compliance: No** 25

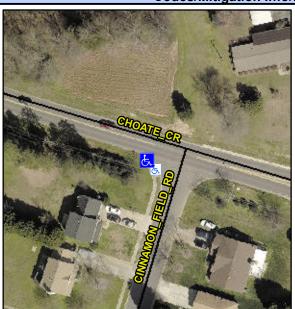
**CHOATE CR** Street 1 Name Stop Condition-Street 2 None Street 2 Name N/A Stop Condition-Street 1 N/A Possible Solutions: Remove & Replace Entire Ramp. Surveyor Notes: N/A PROW/ADA: Not Found, R304.5.3

| Field Measurements/Component Compliance | | | | | | |
|---|---|---|---|---|---|---|
| Yes | Ramp Width (in) | 58.0 | No | Ram | XSlope (%) | 8.1 |
