# Access Compliance Report

## Public Rights-of-Way

### (Curb Ramps)

Intersection ID: 13514	Main Street: WINGATE_AV	Cross Street: OCRACOKE_ST	Location: S
ADA ID: F63215A40A1B	Ramp Type: Perp	Initial Pass/Fail: Fail	Overall Compliance: No
Severity Score: 21.25			
Codes/Mitigation Info/Possible Solution		Field Measurements/Component Compliance

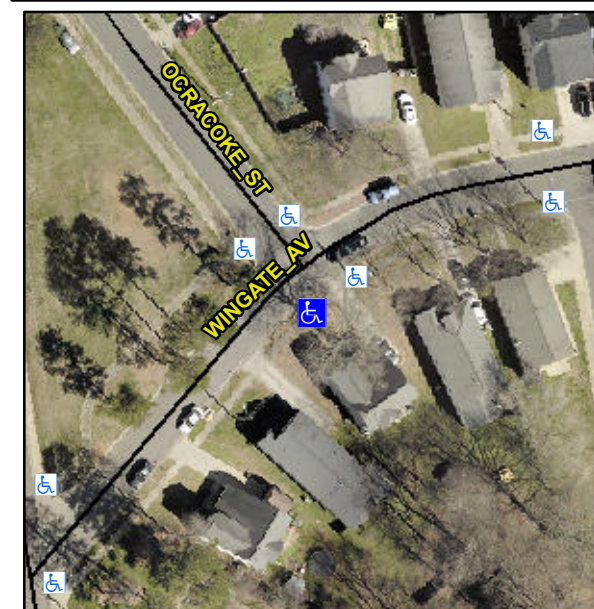
Compliance	Description	Data	Compliance	Description	Data
N/A	Ramp Length (in)	59.0	No	Ramp Slope (%)	9.2
No	Ramp Width (in)	47.0	Yes	Ramp XSlope (%)	1.0
N/A	Flare Type LT	N/A	N/A	Flare Type RT	N/A
N/A	Flare Slope LT (%)	N/A	N/A	Flare Slope RT (%)	N/A
N/A	Flare Traversable LT?	N/A	N/A	Flare Traversable RT?	N/A
N/A	Landing Length (in)	N/A	N/A	DWS Provided?	N/A
N/A	Landing Width (in)	N/A	N/A	DWS Contrast?	N/A
N/A	Landing Slope (%)	N/A	N/A	DWS Length (in)	N/A
N/A	Landing X Slope (%)	N/A	N/A	DWS Full Width?	N/A
N/A	Landing Curb? (Y/N)	N/A	N/A	DWS Offset (in)	N/A
N/A	Shared Landing?	N/A			
N/A	Gutter Ponding?	N/A	N/A	Gutter Slope (%)	N/A
N/A	Gutter Lip Ht (in)	N/A	N/A	Gutter X Slope (%)	N/A
N/A	Painted X Walk1?	No	N/A	Painted X Walk2?	N/A
	X Walk 1 Direction	To N		X Walk 2 Direction	N/A
N/A	X Walk 1 Width (in)	N/A	N/A	X Walk 2 Width (in)	N/A
	X Walk 1 Slope (%)	8.5		X Walk 2 Slope (%)	N/A
	X Walk 1 X Slope (%)	1.6		X Walk 2 X Slope (%)	N/A

N/A	Ramp inside XWalk1?	N/A	N/A	Ramp inside XWalk2?	N/A
	Road Slope (%)	N/A	N/A	Clear Space?	N/A
	Road X Slope (%)	N/A	N/A	Clear Space to XWalk (in)	N/A
N/A	Any Obstructions?	N/A	N/A	Storm Grate/Utility Hazard?	N/A
	Obstruction Type			Storm Grate/Utility Type	
		N/A			N/A
			Yes	Surface Condition? (G/P)	Good

Possible Solutions:

**Remove & Replace Entire Ramp.**

**R304.5.1, R304.2.2**

Total Cost: \$ 1850.00
