Access Compliance Report

Public Rights-of-Way

(Curb Ramps)

Intersection ID: 11943	Main Street: PEGRAM_ST	Cross Street: KENNON_ST	Location: E
ADA ID: F634CE4C577F	Ramp Type: Para	Initial Pass/Fail: Pass	Overall Compliance: No
Severity Score: 0			
Codes/Mitigation Info/Possible Solution		Field Measurements/Component Compliance

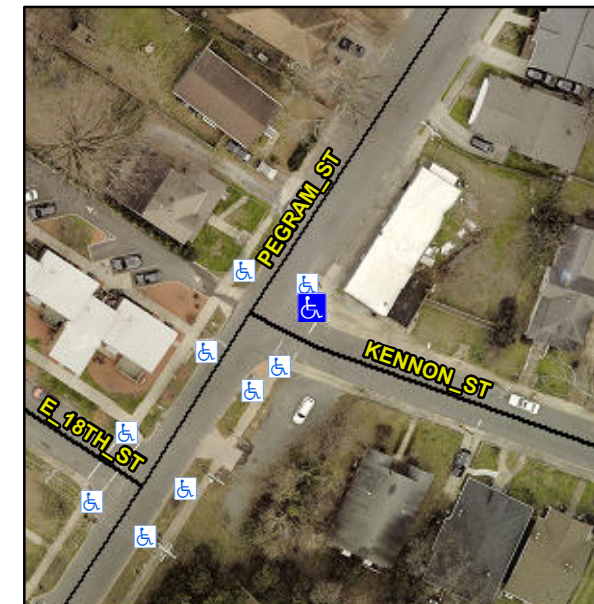
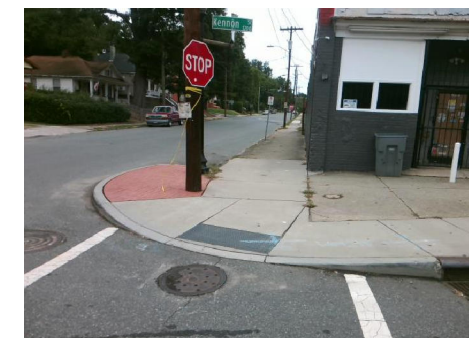
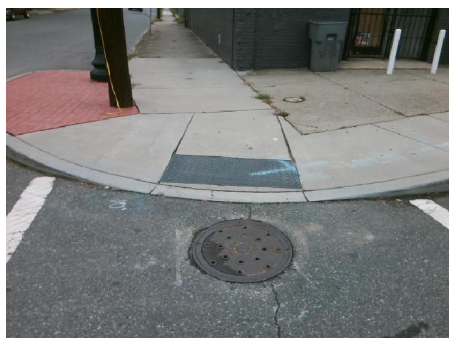
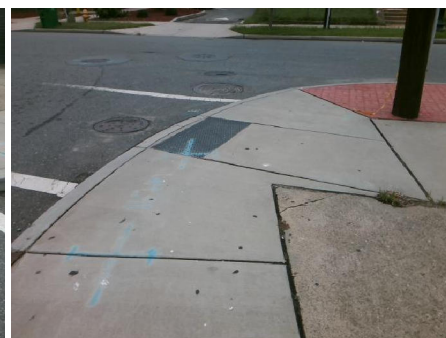
LT RP < 5%

Compliance	Description	Data	Compliance	Description	Data
N/A	Ramp Length LT (in)	28.0	N/A	Ramp Length RT (in)	50.5
Yes	Ramp Width LT (in)	60.0	Yes	Ramp Width RT (in)	58.5
Yes	Ramp Slope LT (%)	4.4	Yes	Ramp Slope RT (%)	6.1
Yes	Ramp XSlope LT (%)	0.7	Yes	Ramp XSlope RT (%)	1.6
Yes	Landing Length (in)	66.0	Yes	DWS Provided?	Yes
No	Landing Width (in)	46.5	Yes	DWS Contrast?	Yes
Yes	Landing Slope (%)	1.8	Yes	DWS Length (in)	24.0
Yes	Landing X Slope (%)	0.4	Yes	DWS Full Width?	Yes
N/A	Landing Curb? (Y/N)	No	No	DWS Offset (in)	4.0
N/A	Shared Landing?	No			
Yes	Gutter Ponding?	No	Yes	Gutter Slope (%)	4.6
Yes	Gutter Lip Ht (in)	0.0	Yes	Gutter X Slope (%)	1.8
N/A	Painted X Walk1?	Yes	N/A	Painted X Walk2?	N/A
	X Walk 1 Direction	To W		X Walk 2 Direction	N/A
N/A	X Walk 1 Width (in)	111.0	N/A	X Walk 2 Width (in)	N/A
	X Walk 1 Slope (%)	3.5		X Walk 2 Slope (%)	N/A
	X Walk 1 X Slope (%)	3.3		X Walk 2 X Slope (%)	N/A
Yes	Ramp inside XWalk1?	Yes	N/A	Ramp inside XWalk2?	N/A

Road Slope (%)	N/A	N/A	Clear Space?	Yes
	Road X Slope (%)	N/A	N/A	Clear Space to XWalk (in)	N/A
Yes	Any Obstructions?	No	Yes	Storm Grate/Utility Hazard?	No
	Obstruction Type			Storm Grate/Utility Type	
		N/A			N/A
			Yes	Surface Condition? (G/P)	Good
			N/A	Curb Slope (%)	N/A

Possible Solutions:

Remove & Replace Entire Ramp.

R304.2.1, R305.2
