# Access Compliance Report

## Public Rights-of-Way

### (Curb Ramps)

| Intersection ID: 49655 | Main Street: GREENWAY_CRESCENT_LN | Cross Street: SEIGLE_POINT_DR | Location: | N |

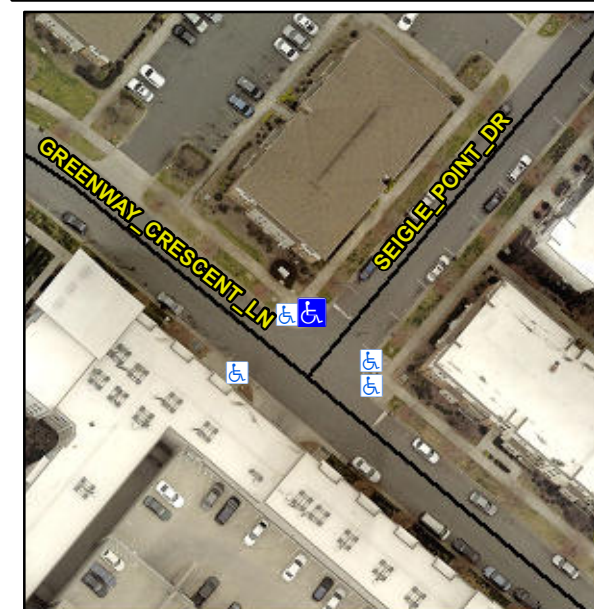
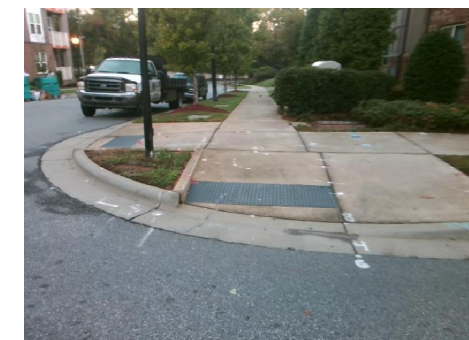
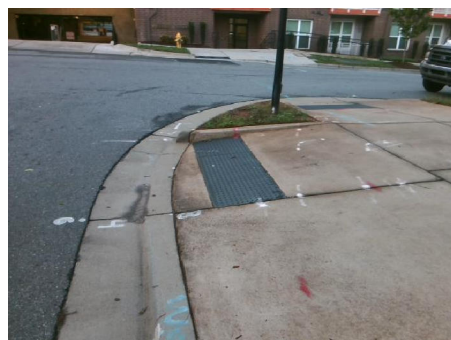
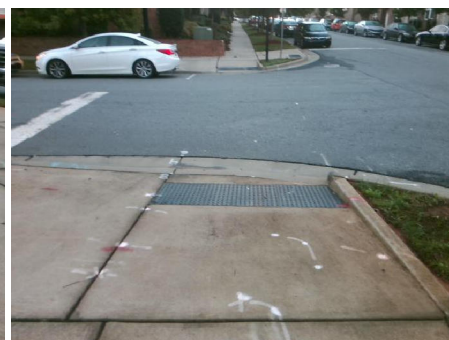
| ADA ID: F63CCB67E2AB | Ramp Type: Directional1 | Initial Pass/Fail: Pass | Overall Compliance: No | Severity Score: 7.5 |

**R304.5.3, R302.7, R302.7.2**

| Compliance | Description | Data | Compliance | Description | Data |
|---|---|---|---|---|---|
| Yes | Ramp Width (in) | 73.0 | No | Grade Break Slope (%) | 5.7 |
| No | Gutter Ponding? | Yes | Yes | Gutter Slope (%) | 3.8 |
| No | Gutter Lip Ht (in) | 0.3 | Yes | Gutter X Slope (%) | 0.9 |

**Remove & Replace Entire Ramp.  
Grind Gutter Lip.**
