# Access Compliance Report

## Public Rights-of-Way

### (Curb Ramps)

Intersection ID: 14706	Main Street: FULLIGER_ST	Cross Street: HIRAM_ST	Location: SW
ADA ID: F68487FD8F0F	Ramp Type: PerpDiag	Initial Pass/Fail: Fail	Overall Compliance: No
Severity Score: 42.5			
Codes/Mitigation Info/Possible Solution		Field Measurements/Component Compliance

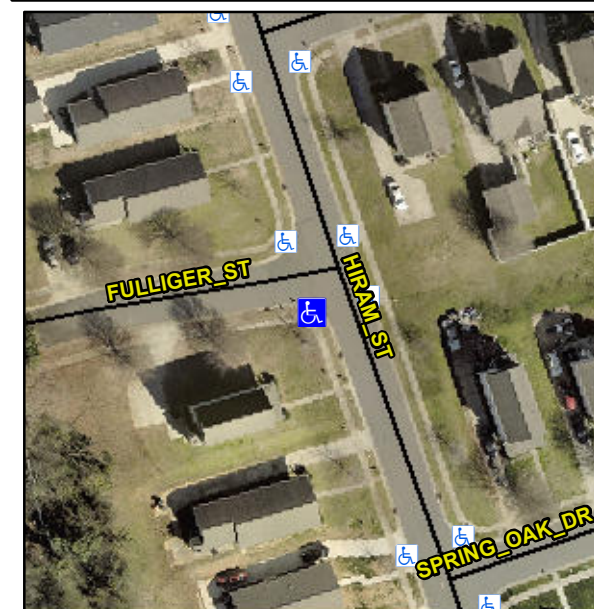
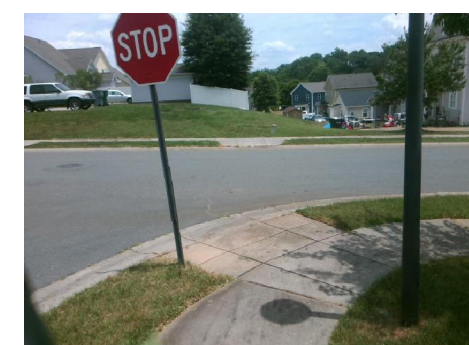
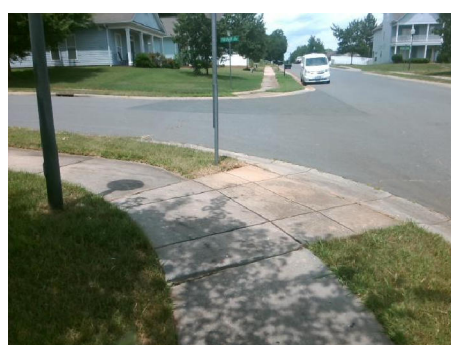
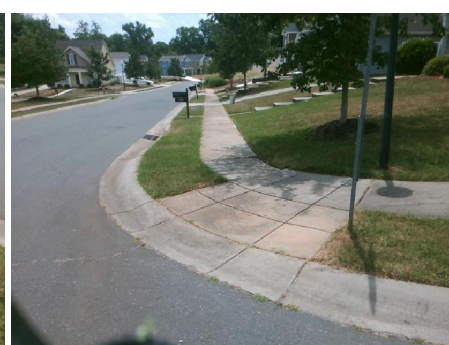
**Not Found, R304.5.1, R304.5.3**

Compliance	Description	Data	Compliance	Description	Data
N/A	Ramp Length (in)	95.0	Yes	Ramp Slope (%)	5.6
No	Ramp Width (in)	34.0	No	Ramp XSlope (%)	9.0
N/A	Flare Type LT	N/A	N/A	Flare Type RT	N/A
N/A	Flare Slope LT (%)	N/A	N/A	Flare Slope RT (%)	N/A
N/A	Flare Traversable LT?	N/A	N/A	Flare Traversable RT?	N/A
N/A	Landing Length (in)	N/A	N/A	DWS Provided?	N/A
N/A	Landing Width (in)	N/A	N/A	DWS Contrast?	N/A
N/A	Landing Slope (%)	N/A	N/A	DWS Length (in)	N/A
N/A	Landing X Slope (%)	N/A	N/A	DWS Full Width?	N/A
N/A	Landing Curb? (Y/N)	N/A	N/A	DWS Offset (in)	N/A
N/A	Shared Landing?	N/A			
N/A	Gutter Ponding?	N/A	N/A	Gutter Slope (%)	N/A
N/A	Gutter Lip Ht (in)	N/A	N/A	Gutter X Slope (%)	N/A
N/A	Painted X Walk1?	No	N/A	Painted X Walk2?	No
	X Walk 1 Direction	To E		X Walk 2 Direction	To N
N/A	X Walk 1 Width (in)	N/A	N/A	X Walk 2 Width (in)	N/A
	X Walk 1 Slope (%)	0.6		X Walk 2 Slope (%)	7.9
	X Walk 1 X Slope (%)	5.8		X Walk 2 X Slope (%)	3.0

N/A	Ramp inside XWalk1?	N/A	N/A	Ramp inside XWalk2?	N/A
	Road Slope (%)	5.1	N/A	Clear Space?	N/A
	Road X Slope (%)	4.4	N/A	Clear Space to XWalk (in)	N/A
N/A	Any Obstructions?	N/A	N/A	Storm Grate/Utility Hazard?	N/A
	Obstruction Type			Storm Grate/Utility Type	
		N/A			N/A
		Yes		Surface Condition? (G/P)	Good

**Remove & Replace Curb Ramp With Two New Directional Ramps or Equivalent.**
