Access Compliance Report

Public Rights-of-Way

(Curb Ramps)

Intersection ID: 52919	Main Street: HOOVER_CREEK_BV	Cross Street: WALKER_BRANCH_DR	Location: SW
ADA ID: F69C0AC52D62	Ramp Type: PerpDiag	Initial Pass/Fail: Fail	Overall Compliance: No
Severity Score: 13.75			
Codes/Mitigation Info/Possible Solution		Field Measurements/Component Compliance

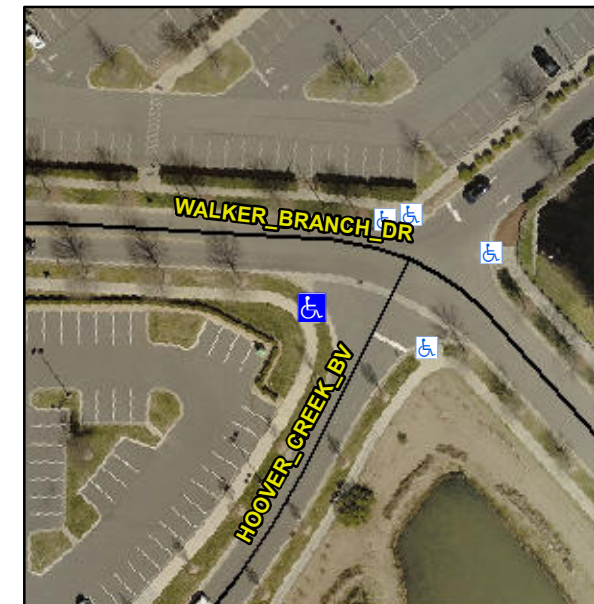
Not Found, R304.2.2, R304.5.3

Compliance	Description	Data	Compliance	Description	Data
N/A	Ramp Length (in)	86.0	No	Ramp Slope (%)	9.5
Yes	Ramp Width (in)	48.0	No	Ramp XSlope (%)	3.9
N/A	Flare Type LT	N/A	N/A	Flare Type RT	N/A
N/A	Flare Slope LT (%)	N/A	N/A	Flare Slope RT (%)	N/A
N/A	Flare Traversable LT?	N/A	N/A	Flare Traversable RT?	N/A
N/A	Landing Length (in)	N/A	N/A	DWS Provided?	N/A
N/A	Landing Width (in)	N/A	N/A	DWS Contrast?	N/A
N/A	Landing Slope (%)	N/A	N/A	DWS Length (in)	N/A
N/A	Landing X Slope (%)	N/A	N/A	DWS Full Width?	N/A
N/A	Landing Curb? (Y/N)	N/A	N/A	DWS Offset (in)	N/A
N/A	Shared Landing?	N/A			
N/A	Gutter Ponding?	N/A	N/A	Gutter Slope (%)	N/A
N/A	Gutter Lip Ht (in)	N/A	N/A	Gutter X Slope (%)	N/A
N/A	Painted X Walk1?	No	N/A	Painted X Walk2?	No
	X Walk 1 Direction	To SE		X Walk 2 Direction	To NE
N/A	X Walk 1 Width (in)	N/A	N/A	X Walk 2 Width (in)	N/A
	X Walk 1 Slope (%)	2.9		X Walk 2 Slope (%)	1.9
	X Walk 1 X Slope (%)	0.6		X Walk 2 X Slope (%)	3.0

N/A	Ramp inside XWalk1?	N/A	N/A	Ramp inside XWalk2?	N/A
	Road Slope (%)	3.1	N/A	Clear Space?	N/A
	Road X Slope (%)	0.9	N/A	Clear Space to XWalk (in)	N/A
N/A	Any Obstructions?	N/A	N/A	Storm Grate/Utility Hazard?	N/A
	Obstruction Type			Storm Grate/Utility Type	
		N/A			N/A
			Yes	Surface Condition? (G/P)	Good

Remove & Replace Curb Ramp With Two New Directional Ramps or Equivalent.
