# Access Compliance Report

## Public Rights-of-Way

### (Curb Ramps)

Intersection ID: 10023487	Main Street: CIRCUMFERENTIAL_RD	Cross Street: N/A	Location:	N
ADA ID: F6A694893D63	Ramp Type: PerpDiag	Initial Pass/Fail: Fail	Overall Compliance: No	Severity Score: 25
Codes/Mitigation Info/Possible Solution		Field Measurements/Component Compliance

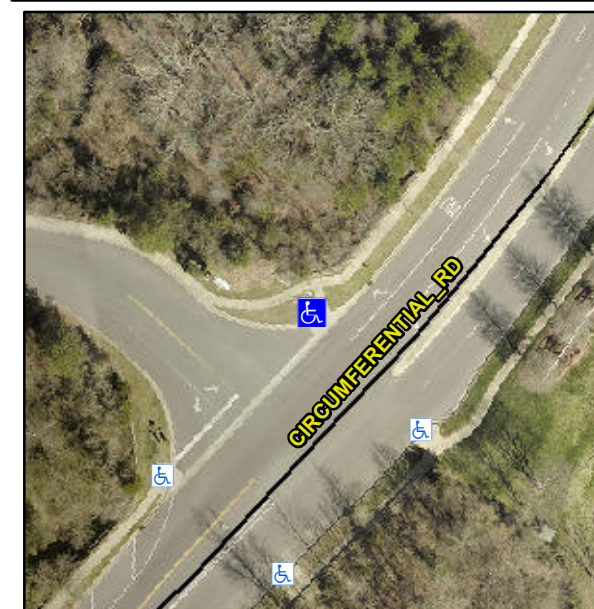
**Not Found, R304.2.2, R304.5.3**

Compliance	Description	Data	Compliance	Description	Data
N/A	Ramp Length (in)	61.0	No	Ramp Slope (%)	9.3
Yes	Ramp Width (in)	48.0	No	Ramp XSlope (%)	5.9
N/A	Flare Type LT	N/A	N/A	Flare Type RT	N/A
N/A	Flare Slope LT (%)	N/A	N/A	Flare Slope RT (%)	N/A
N/A	Flare Traversable LT?	N/A	N/A	Flare Traversable RT?	N/A
N/A	Landing Length (in)	N/A	N/A	DWS Provided?	N/A
N/A	Landing Width (in)	N/A	N/A	DWS Contrast?	N/A
N/A	Landing Slope (%)	N/A	N/A	DWS Length (in)	N/A
N/A	Landing X Slope (%)	N/A	N/A	DWS Full Width?	N/A
N/A	Landing Curb? (Y/N)	N/A	N/A	DWS Offset (in)	N/A
N/A	Shared Landing?	N/A			
N/A	Gutter Ponding?	N/A	N/A	Gutter Slope (%)	N/A
N/A	Gutter Lip Ht (in)	N/A	N/A	Gutter X Slope (%)	N/A
N/A	Painted X Walk1?	No	N/A	Painted X Walk2?	No
	X Walk 1 Direction	To SW		X Walk 2 Direction	To SE
N/A	X Walk 1 Width (in)	N/A	N/A	X Walk 2 Width (in)	N/A
	X Walk 1 Slope (%)	1.7		X Walk 2 Slope (%)	1.0
	X Walk 1 X Slope (%)	3.0		X Walk 2 X Slope (%)	3.7

N/A	Ramp inside XWalk1?	N/A	N/A	Ramp inside XWalk2?	N/A
	Road Slope (%)	1.3	N/A	Clear Space?	N/A
	Road X Slope (%)	2.0	N/A	Clear Space to XWalk (in)	N/A
N/A	Any Obstructions?	N/A	N/A	Storm Grate/Utility Hazard?	N/A
	Obstruction Type			Storm Grate/Utility Type	
		N/A			N/A
			Yes	Surface Condition? (G/P)	Good

**Remove & Replace Curb Ramp With Two New Directional Ramps or Equivalent.**
