# Access Compliance Report

## Public Rights-of-Way

### (Curb Ramps)

| Intersection ID: 48633 | Main Street: GRANDE HEIGHTS DR | Cross Street: MILLSTREAM RIDGE DR | Location: S |

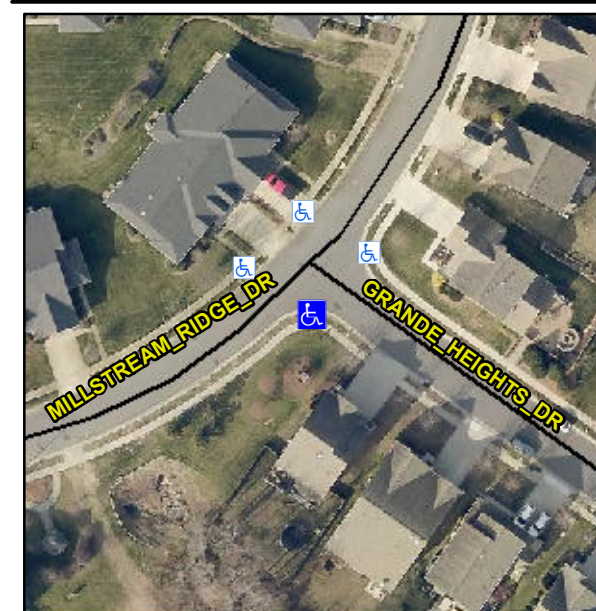
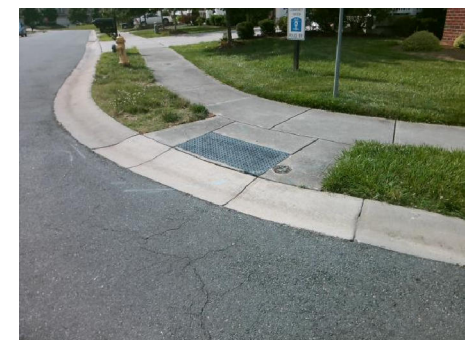
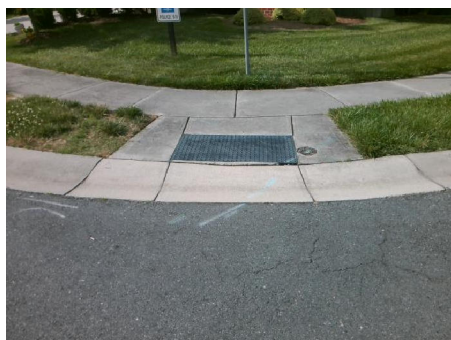
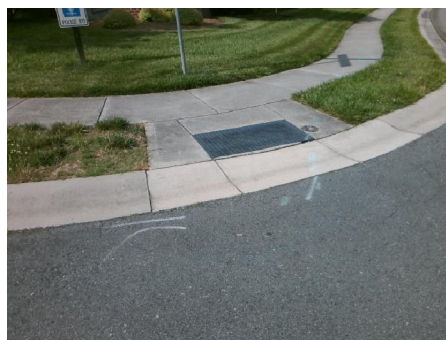
**Not Found, R304.5.3, R305.1.4, R302.7.2, R304.5.4**

| Compliance | Description | Data | Compliance | Description | Data |
|---|---|---|---|---|---|
| Yes | Ramp Width (in) | 48.0 | No | BlendTrans XSlope (%) | 4.1 |
| No | Landing X Slope (%) | 4.4 | No | DWS Full Width? | No |
| Yes | Gutter Ponding? | No | No | Gutter Slope (%) | 6.2 |
| No | Gutter Lip Ht (in) | 1.0 | No | Gutter X Slope (%) | 3.9 |
| | | | No | Curb Slope (%) | 13.9 |

**Remove & Replace Curb Ramp With Two New Directional Ramps or Equivalent. Remove & Replace Gutter.**
