Access Compliance Report

Public Rights-of-Way (Curb Ramps)

| Intersection ID: 51509 | Main Street: EASTFIELD_PARK_DR | Cross Street: NETHERTON_LN | Location: S |
| ADA ID: F6C1C7282E29 | Ramp Type: Perp | Initial Pass/Fail: Pass | Overall Compliance: No |

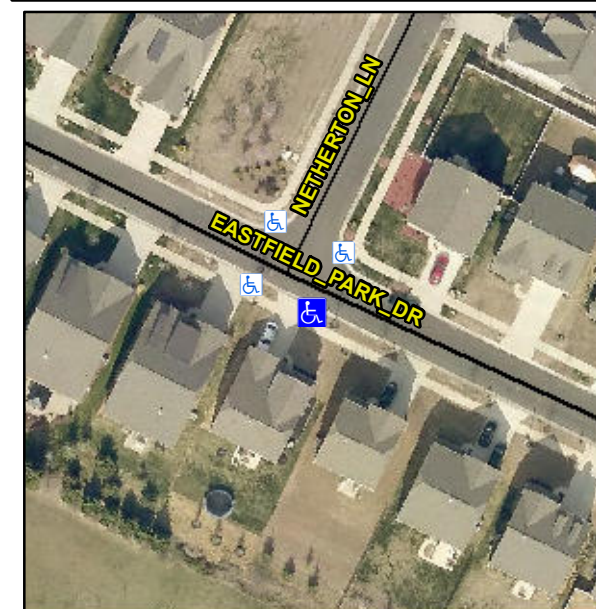
Not Found, R305.2, R304.5.4

| Compliance | Description | Data | Compliance | Description | Data |
|---|---|---|---|---|---|
| N/A | Landing Curb? (Y/N) | No | No | DWS Offset (in) | 4.0 |
| Yes | Gutter Ponding? | No | No | Gutter Slope (%) | 5.2 |

Possible Solutions:

**Remove & Replace Entire Ramp.
Remove & Replace Gutter.**
