Access Compliance Report

Public Rights-of-Way

(Curb Ramps)

Intersection ID: 10015810	Main Street: STATESVILLE_AV	Cross Street: CARMINE_ST	Location: SW
ADA ID: F6C4C25DB536	Ramp Type: PerpDiag	Initial Pass/Fail: Fail	Overall Compliance: No
Severity Score: 22.5			
Codes/Mitigation Info/Possible Solution		Field Measurements/Component Compliance

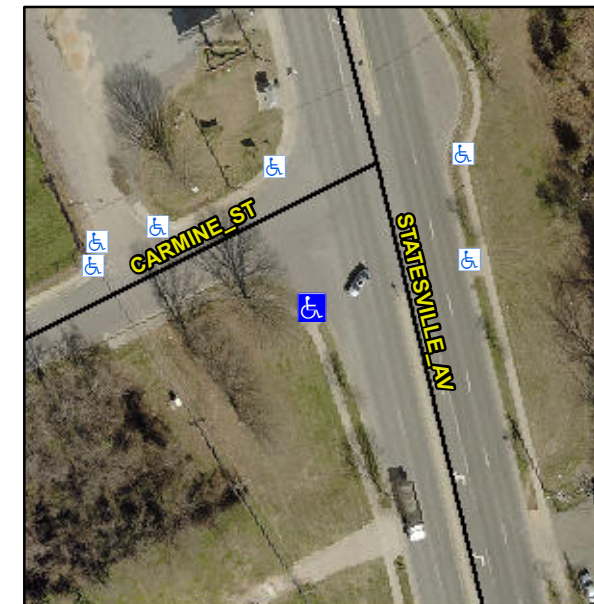
Not Found, R304.5.1, R304.2.2, R304.5.3

Compliance	Description	Data	Compliance	Description	Data
N/A	Ramp Length (in)	58.0	No	Ramp Slope (%)	8.5
No	Ramp Width (in)	40.5	No	Ramp XSlope (%)	3.2
N/A	Flare Type LT	N/A	N/A	Flare Type RT	N/A
N/A	Flare Slope LT (%)	N/A	N/A	Flare Slope RT (%)	N/A
N/A	Flare Traversable LT?	N/A	N/A	Flare Traversable RT?	N/A
N/A	Landing Length (in)	N/A	N/A	DWS Provided?	N/A
N/A	Landing Width (in)	N/A	N/A	DWS Contrast?	N/A
N/A	Landing Slope (%)	N/A	N/A	DWS Length (in)	N/A
N/A	Landing X Slope (%)	N/A	N/A	DWS Full Width?	N/A
N/A	Landing Curb? (Y/N)	N/A	N/A	DWS Offset (in)	N/A
N/A	Shared Landing?	N/A			
N/A	Gutter Ponding?	N/A	N/A	Gutter Slope (%)	N/A
N/A	Gutter Lip Ht (in)	N/A	N/A	Gutter X Slope (%)	N/A
N/A	Painted X Walk1?	No	N/A	Painted X Walk2?	No
	X Walk 1 Direction	To E		X Walk 2 Direction	To N
N/A	X Walk 1 Width (in)	N/A	N/A	X Walk 2 Width (in)	N/A
	X Walk 1 Slope (%)	2.8		X Walk 2 Slope (%)	5.5
	X Walk 1 X Slope (%)	4.0		X Walk 2 X Slope (%)	0.5

N/A	Ramp inside XWalk1?	N/A	N/A	Ramp inside XWalk2?	N/A
	Road Slope (%)	3.9	N/A	Clear Space?	N/A
	Road X Slope (%)	5.6	N/A	Clear Space to XWalk (in)	N/A
N/A	Any Obstructions?	N/A	N/A	Storm Grate/Utility Hazard?	N/A
	Obstruction Type			Storm Grate/Utility Type	
		N/A			N/A
		Yes		Surface Condition? (G/P)	Good

Remove & Replace Curb Ramp With Two New Directional Ramps or Equivalent.
