Access Compliance Report

Public Rights-of-Way

(Curb Ramps)

| Intersection ID: 14393 | Main Street: BERKELEY_AV | Cross Street: LEXINGTON_AV | Location: SW |

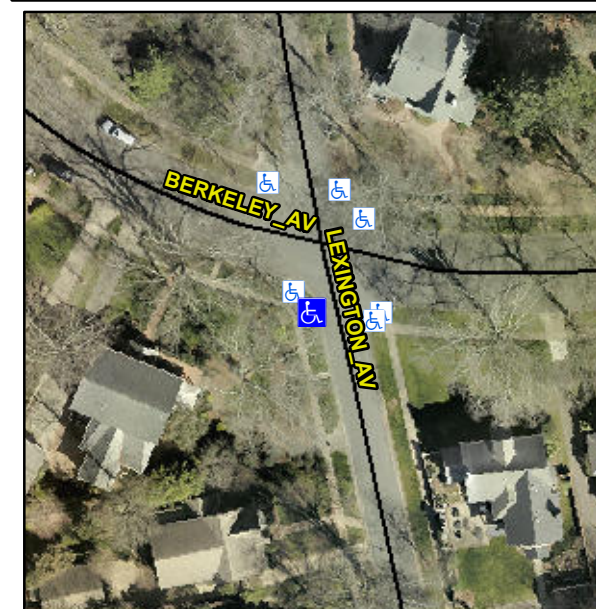
| ADA ID: F6C4D1C85D6A | Ramp Type: Perp | Initial Pass/Fail: Fail | Overall Compliance: No |
| Severity Score: 1.25 | | | |

Not Found, R304.5.3

| Compliance | Description | Data | Compliance | Description | Data |
|---|---|---|---|---|---|
| N/A | Ramp Length (in) | 96.0 | Yes | Ramp Slope (%) | 8.2 |
| Yes | Ramp Width (in) | 60.0 | No | Ramp XSlope (%) | 2.2 |

Possible Solutions:

Remove & Replace Entire Ramp.
