Access Compliance Report

Public Rights-of-Way

(Curb Ramps)

Intersection ID: 30067	Main Street: OHAUS_CT	Cross Street: WATERS_TRAIL_DR	Location: NW
ADA ID: F6C7DA46A1D1	Ramp Type: BlendTrans2	Initial Pass/Fail: Fail	Overall Compliance: No
Severity Score: 10			
Codes/Mitigation Info/Possible Solution		Field Measurements/Component Compliance

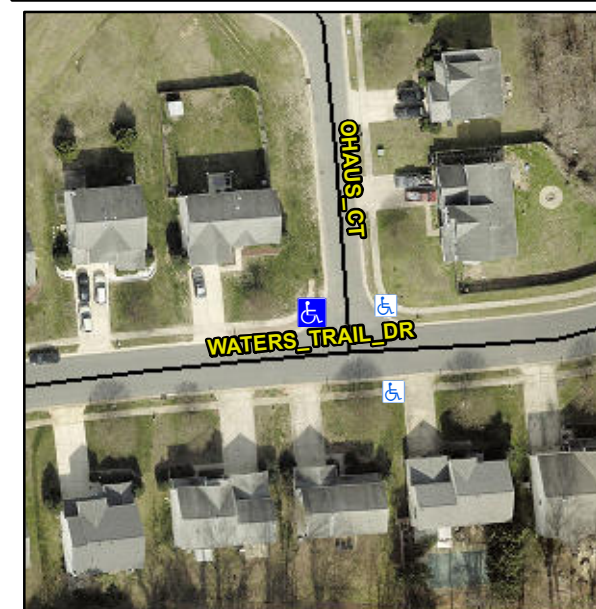
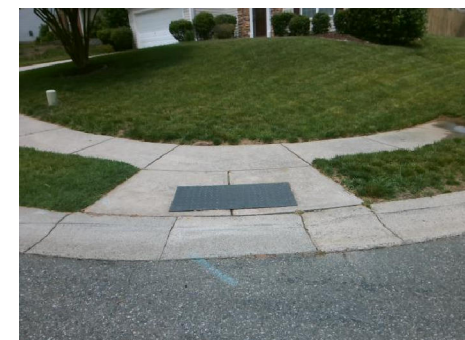
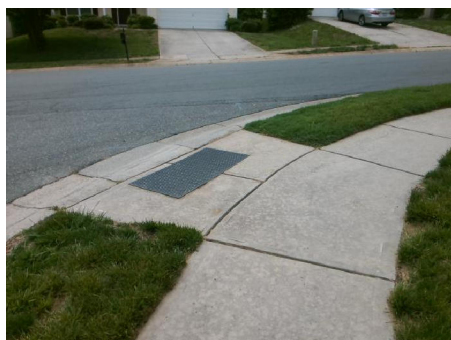
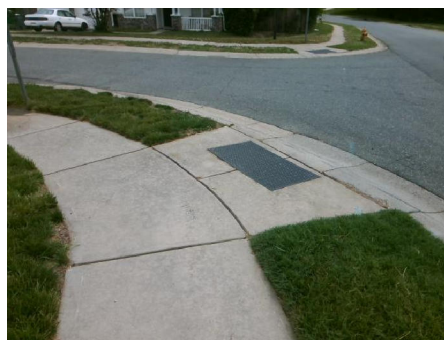
Not Found, R304.5.1, R304.5.3

Compliance	Description	Data	Compliance	Description	Data
N/A	Ramp Length (in)	94.5	Yes	BlendTrans Slope (%)	3.0
No	Ramp Width (in)	44.0	No	BlendTrans XSlope (%)	4.1
N/A	Flare Type LT	N/A	N/A	Flare Type RT	N/A
N/A	Flare Slope LT (%)	N/A	N/A	Flare Slope RT (%)	N/A
N/A	Flare Traversable LT?	N/A	N/A	Flare Traversable RT?	N/A
N/A	Landing Length (in)	N/A	N/A	DWS Provided?	N/A
N/A	Landing Width (in)	N/A	N/A	DWS Contrast?	N/A
N/A	Landing Slope (%)	N/A	N/A	DWS Length (in)	N/A
N/A	Landing X Slope (%)	N/A	N/A	DWS Full Width?	N/A
N/A	Landing Curb? (Y/N)	N/A	N/A	DWS Offset (in)	N/A
N/A	Shared Landing?	N/A			
N/A	Gutter Ponding?	N/A	N/A	Gutter Slope (%)	N/A
N/A	Gutter Lip Ht (in)	N/A	N/A	Gutter X Slope (%)	N/A
N/A	Painted X Walk1?	No	N/A	Painted X Walk2?	No
	X Walk 1 Direction	To E		X Walk 2 Direction	To S
	X Walk 1 Width (in)	N/A		X Walk 2 Width (in)	N/A
	X Walk 1 Slope (%)	2.3		X Walk 2 Slope (%)	3.3
	X Walk 1 X Slope (%)	2.6		X Walk 2 X Slope (%)	3.0

N/A	Ramp inside XWalk1?	N/A	N/A	Ramp inside XWalk2?	N/A
	Road Slope (%)	3.5		Clear Space?	N/A
	Road X Slope (%)	2.0	N/A	Clear Space to XWalk (in)	N/A
N/A	Any Obstructions?	N/A	N/A	Storm Grate/Utility Hazard?	N/A
	Obstruction Type			Storm Grate/Utility Type	
		N/A			N/A
			Yes	Surface Condition? (G/P)	Good
			No	Curb Slope (%)	12.4

Remove & Replace Curb Ramp With Two New Directional Ramps or Equivalent.
