# Access Compliance Report

## Public Rights-of-Way

### (Curb Ramps)

Intersection ID: 10037289	Main Street: SARDIS_RD_NORTH	Cross Street: N/A	Location: SE
ADA ID: F6D4546961FC	Ramp Type: Para	Initial Pass/Fail: Fail	Overall Compliance: No
Codes/Mitigation Info/Possible Solution		Field Measurements/Component Compliance	
		Severity Score: 25

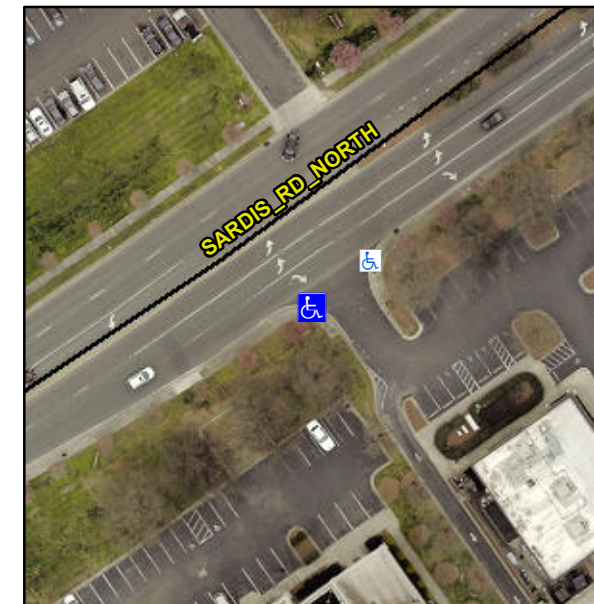
**R304.5.3, R304.3.2**

Compliance	Description	Data	Compliance	Description	Data
N/A	Ramp Length LT (in)	70.0	N/A	Ramp Length RT (in)	76.0
Yes	Ramp Width LT (in)	60.0	Yes	Ramp Width RT (in)	57.0
Yes	Ramp Slope LT (%)	7.6	No	Ramp Slope RT (%)	8.9
No	Ramp XSlope LT (%)	4.2	No	Ramp XSlope RT (%)	6.6
N/A	Landing Length (in)	N/A	N/A	DWS Provided?	N/A
N/A	Landing Width (in)	N/A	N/A	DWS Contrast?	N/A
N/A	Landing Slope (%)	N/A	N/A	DWS Length (in)	N/A
N/A	Landing X Slope (%)	N/A	N/A	DWS Full Width?	N/A
N/A	Landing Curb? (Y/N)	N/A	N/A	DWS Offset (in)	N/A
N/A	Shared Landing?	N/A			
N/A	Gutter Ponding?	N/A	N/A	Gutter Slope (%)	N/A
N/A	Gutter Lip Ht (in)	N/A	N/A	Gutter X Slope (%)	N/A
N/A	Painted X Walk1?	No	N/A	Painted X Walk2?	N/A
	X Walk 1 Direction	To NE		X Walk 2 Direction	N/A
N/A	X Walk 1 Width (in)	N/A	N/A	X Walk 2 Width (in)	N/A
	X Walk 1 Slope (%)	1.0		X Walk 2 Slope (%)	N/A
	X Walk 1 X Slope (%)	0.5		X Walk 2 X Slope (%)	N/A
N/A	Ramp inside XWalk1?	N/A	N/A	Ramp inside XWalk2?	N/A

**Remove & Replace Entire Ramp.**
