# Access Compliance Report

## Public Rights-of-Way

### (Curb Ramps)

Intersection ID: 12761	Main Street: S_MINT_ST	Cross Street: W_CARSON_BV	Location: W
ADA ID: F6F475F5C9B7	Ramp Type: PerpDiag	Initial Pass/Fail: Fail	Overall Compliance: No
Severity Score: 12.5			
Codes/Mitigation Info/Possible Solution		Field Measurements/Component Compliance

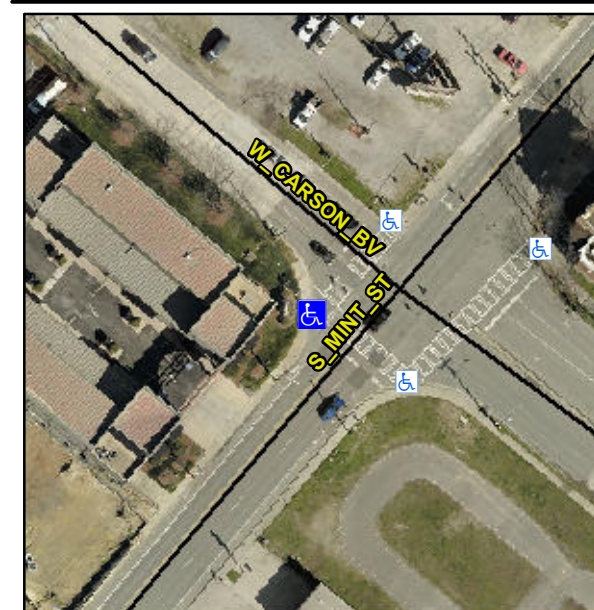
Compliance	Description	Data	Compliance	Description	Data
N/A	Ramp Length (in)	53.0	No	Ramp Slope (%)	9.1
Yes	Ramp Width (in)	48.0	Yes	Ramp XSlope (%)	0.6
N/A	Flare Type LT	N/A	N/A	Flare Type RT	N/A
N/A	Flare Slope LT (%)	N/A	N/A	Flare Slope RT (%)	N/A
N/A	Flare Traversable LT?	N/A	N/A	Flare Traversable RT?	N/A
N/A	Landing Length (in)	N/A	N/A	DWS Provided?	N/A
N/A	Landing Width (in)	N/A	N/A	DWS Contrast?	N/A
N/A	Landing Slope (%)	N/A	N/A	DWS Length (in)	N/A
N/A	Landing X Slope (%)	N/A	N/A	DWS Full Width?	N/A
N/A	Landing Curb? (Y/N)	N/A	N/A	DWS Offset (in)	N/A
N/A	Shared Landing?	N/A			
N/A	Gutter Ponding?	N/A	N/A	Gutter Slope (%)	N/A
N/A	Gutter Lip Ht (in)	N/A	N/A	Gutter X Slope (%)	N/A
N/A	Painted X Walk1?	Yes	N/A	Painted X Walk2?	Yes
	X Walk 1 Direction	To SE		X Walk 2 Direction	To NE
N/A	X Walk 1 Width (in)	110.0	N/A	X Walk 2 Width (in)	110.0
	X Walk 1 Slope (%)	2.9		X Walk 2 Slope (%)	1.3
	X Walk 1 X Slope (%)	0.1		X Walk 2 X Slope (%)	0.4

N/A	Ramp inside XWalk1?	Yes	N/A	Ramp inside XWalk2?	No
	Road Slope (%)	0.5	N/A	Clear Space?	N/A
	Road X Slope (%)	2.0	N/A	Clear Space to XWalk (in)	N/A
N/A	Any Obstructions?	N/A	N/A	Storm Grate/Utility Hazard?	N/A
	Obstruction Type			Storm Grate/Utility Type	
		N/A			N/A
		Yes		Surface Condition? (G/P)	Good

Possible Solutions:

**Remove & Replace Curb Ramp With Two New Directional Ramps or Equivalent. Restripe Crosswalk.**
