# Access Compliance Report

## Public Rights-of-Way

### (Curb Ramps)

Intersection ID: 15072	Main Street: DILWORTH_RD_EAST	Cross Street: E WORTHINGTON AV	Location: S
ADA ID: F6FB73C8A7B4	Ramp Type: Directional1	Initial Pass/Fail: Fail	Overall Compliance: No
Severity Score: 12.5			
Codes/Mitigation Info/Possible Solution		Field Measurements/Component Compliance

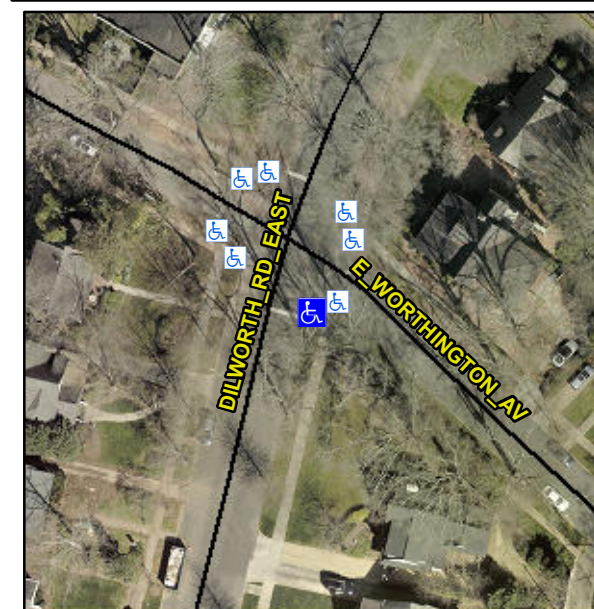
**DAMAGED DWS**

Compliance	Description	Data	Compliance	Description	Data
N/A	Ramp Length (in)	117.0	N/A	Grade Break?	N/A
Yes	Ramp Width (in)	60.0	N/A	Grade Break Slope (%)	0.0
Yes	Ramp Slope (%)	5.3	N/A	Grade Break XSlope (%)	0.0
No	Ramp XSlope (%)	5.9			
N/A	Flare Type LT	N/A	N/A	Flare Type RT	N/A
N/A	Flare Slope LT (%)	N/A	N/A	Flare Slope RT (%)	0.0
N/A	Flare Traversable LT?	N/A	N/A	Flare Traversable RT?	N/A
N/A	Landing Length (in)	0.0	N/A	DWS Provided?	N/A
N/A	Landing Width (in)	0.0	N/A	DWS Contrast?	N/A
N/A	Landing Slope (%)	0.0	N/A	DWS Length (in)	N/A
N/A	Landing X Slope (%)	0.0	N/A	DWS Full Width?	N/A
N/A	Landing Curb? (Y/N)	N/A	N/A	DWS Offset LT (in)	N/A
N/A	Shared Landing?	N/A	N/A	DWS Offset RT (in)	N/A
N/A	Gutter Ponding?	0.0	N/A	Gutter Slope (%)	N/A
N/A	Gutter Lip Ht (in)	0.0	N/A	Gutter X Slope (%)	N/A
N/A	Painted X Walk1?	No		Road Slope (%)	3.6
	X Walk 1 Direction	To NW		Road X Slope (%)	2.2
	X Walk 1 Width (in)	N/A		Clear Space?	N/A

X Walk 1 Slope (%)	3.6	N/A	Clear Space to XWalk (in)	N/A
	X Walk 1 X Slope (%)	2.2	N/A	Storm Grate/Utility Hazard?	N/A
N/A	Ramp inside XWalk1?	N/A		Storm Grate/Utility Type	
N/A	Any Obstructions?	N/A			N/A
	Obstruction Type		Yes	Surface Condition? (G/P)	Good
			N/A	Curb Slope (%)	0.7

**Remove & Replace Entire Ramp.**

Total Cost: \$ 1600.00
