# Access Compliance Report

## Public Rights-of-Way (Curb Ramps)

Intersection ID: 29952	Main Street: CANIPE_DR	Cross Street: DAVIS_RIDGE_DR	Location: E
ADA ID: F707B0D487C7	Ramp Type: PerpDiag	Initial Pass/Fail: Fail	Overall Compliance: No
		Severity Score: 8.75

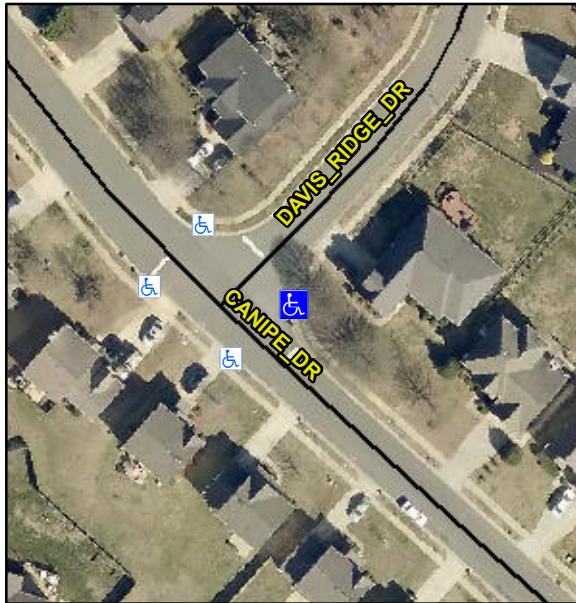
**Not Found, R304.5.1**

Compliance	Description	Data	Compliance	Description	Data
N/A	Ramp Length (in)	49.0	Yes	Ramp Slope (%)	5.1
No	Ramp Width (in)	47.5	Yes	Ramp XSlope (%)	1.4
N/A	Flare Type LT	N/A	N/A	Flare Type RT	N/A
N/A	Flare Slope LT (%)	N/A	N/A	Flare Slope RT (%)	N/A
N/A	Flare Traversable LT?	N/A	N/A	Flare Traversable RT?	N/A
N/A	Landing Length (in)	N/A	N/A	DWS Provided?	N/A
N/A	Landing Width (in)	N/A	N/A	DWS Contrast?	N/A
N/A	Landing Slope (%)	N/A	N/A	DWS Length (in)	N/A
N/A	Landing X Slope (%)	N/A	N/A	DWS Full Width?	N/A
N/A	Landing Curb? (Y/N)	N/A	N/A	DWS Offset (in)	N/A
N/A	Shared Landing?	N/A			
N/A	Gutter Ponding?	N/A	N/A	Gutter Slope (%)	N/A
N/A	Gutter Lip Ht (in)	N/A	N/A	Gutter X Slope (%)	N/A
N/A	Painted X Walk1?	No	N/A	Painted X Walk2?	No
	X Walk 1 Direction	To SE		X Walk 2 Direction	To SW
N/A	X Walk 1 Width (in)	N/A	N/A	X Walk 2 Width (in)	N/A
	X Walk 1 Slope (%)	3.7		X Walk 2 Slope (%)	7.4
	X Walk 1 X Slope (%)	0.8		X Walk 2 X Slope (%)	5.4

N/A	Ramp inside XWalk1?	N/A	N/A	Ramp inside XWalk2?	N/A
	Road Slope (%)	1.6	N/A	Clear Space?	N/A
	Road X Slope (%)	5.2	N/A	Clear Space to XWalk (in)	N/A
N/A	Any Obstructions?	N/A	N/A	Storm Grate/Utility Hazard?	N/A
	Obstruction Type			Storm Grate/Utility Type	
		N/A			N/A
			Yes	Surface Condition? (G/P)	Good

**Remove & Replace Curb Ramp With Two New Directional Ramps or Equivalent.**
