Access Compliance Report Public Rights-of-Way (Curb Ramps)

Intersection ID: 14095	Main Street: CAMDEN_RD			Cross	Street:	W_WORTHINGTON_	Location:	NE			
ADA ID: F7251F16779E	Ramp T	Ramp Type: Perp			Initial Pass/Fail: Fail Overall Compliance: No				o Severity Score:	13.75	
Codes/Mitigation Info/Possible Solution					Field Measurements/Component Compliance						
10 1 1 1 1 1 1 1 1 1 1 1 1 1 1 1 1 1 1	1 del Tri	Possible Solutions:						ta Compliance Description Data			
1 1 1 1 1 1 1 1 1 1 1 1 1 1 1 1 1 1 1		Remove & Replace Enti	re Ram	o.	N/A	Ramp Length (in)	96.0	No	Ramp Slope (%)	10.2	
NAS . NSI / 6	1. Aler				Yes	Ramp Width (in)	128.0	No	Ramp XSlope (%)	2.6	
1 Martin & MININ	1 MAS 1 Gran				N/A	Flare Type LT	N/A	N/A	Flare Type RT	N/A	
Jor all 194	111111				N/A	Flare Slope LT (%)	N/A	N/A	Flare Slope RT (%)	N/A	
	111222				N/A	Flare Traversable LT?	N/A	N/A	Flare Traversable RT?	N/A	
	ALL STORE				N/A	Landing Length (in)	N/A	N/A	DWS Provided?	N/A

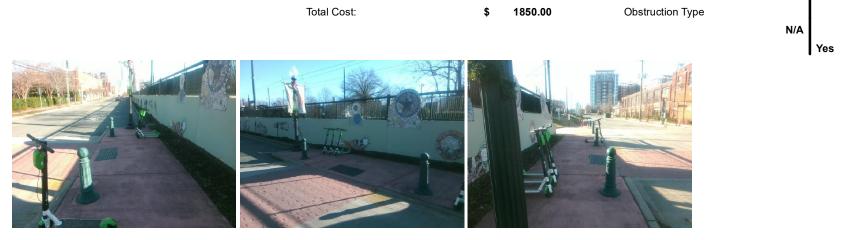
- B - 76				N/A	Shared Landing?	N/A				
	0	PROW/ADA:			N/A	Gutter Ponding?	N/A	N/A	Gutter Slope (%)	N/A	
E IN I A MARK	USE !!	Not Found, R304.2.2, R3	304.5.3		N/A	Gutter Lip Ht (in)	N/A	N/A	Gutter X Slope (%)	N/A	
	and the second se	,			N/A	Painted X Walk1?	Yes	N/A	Painted X Walk2?	N/A	
1 She Market						X Walk 1 Direction	To NW		X Walk 2 Direction	N/A	
ALE TRANSFORMER				N/A	X Walk 1 Width (in)	130.0	N/A	X Walk 2 Width (in)	N/A		
Street 1 Name	CAMDEN RD	-				X Walk 1 Slope (%)	2.0		X Walk 2 Slope (%)	N/A	
Stop Condition-Street 2	None					X Walk 1 X Slope (%)	0.4		X Walk 2 X Slope (%)	N/A	
Street 2 Name	N/A				N/A	Ramp inside XWalk1?	Yes	N/A	Ramp inside XWalk2?	N/A	
Stop Condition-Street 1	N/A					Road Slope (%)	N/A	N/A	Clear Space?	N/A	
						Road X Slope (%)	N/A	N/A	Clear Space to XWalk (in)	N/A	
					N/A	Any Obstructions?	N/A	N/A	Storm Grate/Utility Hazard?	N/A	
		Total Cost:	\$	1850.00		Obstruction Type			Storm Grate/Utility Type
