# Access Compliance Report

## Public Rights-of-Way

### (Curb Ramps)

Intersection ID: 50605	Main Street: DENBUR_DR	Cross Street: RHODORA_RD	Location: W
ADA ID: F73962195016	Ramp Type: Perp	Initial Pass/Fail: Fail	Overall Compliance: No
Severity Score: 22.5			
Codes/Mitigation Info/Possible Solution		Field Measurements/Component Compliance

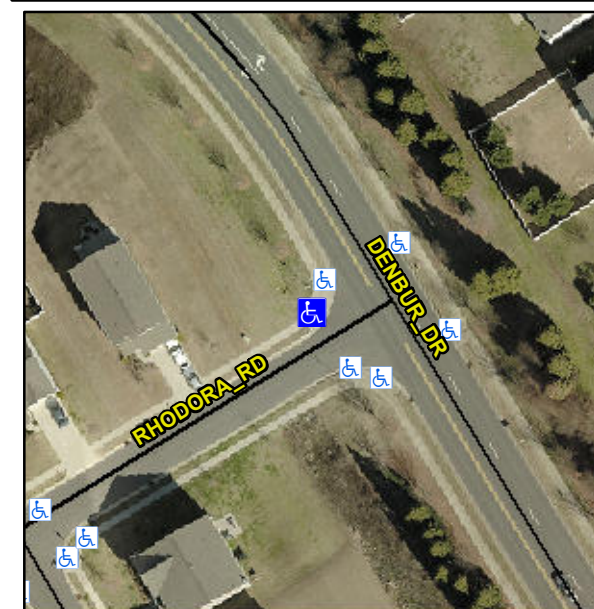
**Not Found, R304.5.1, R304.2.2, R304.5.3**

Compliance	Description	Data	Compliance	Description	Data
N/A	Ramp Length (in)	50.5	No	Ramp Slope (%)	8.7
No	Ramp Width (in)	46.0	No	Ramp XSlope (%)	2.1
N/A	Flare Type LT	N/A	N/A	Flare Type RT	N/A
N/A	Flare Slope LT (%)	N/A	N/A	Flare Slope RT (%)	N/A
N/A	Flare Traversable LT?	N/A	N/A	Flare Traversable RT?	N/A
N/A	Landing Length (in)	N/A	N/A	DWS Provided?	N/A
N/A	Landing Width (in)	N/A	N/A	DWS Contrast?	N/A
N/A	Landing Slope (%)	N/A	N/A	DWS Length (in)	N/A
N/A	Landing X Slope (%)	N/A	N/A	DWS Full Width?	N/A
N/A	Landing Curb? (Y/N)	N/A	N/A	DWS Offset (in)	N/A
N/A	Shared Landing?	N/A			
N/A	Gutter Ponding?	N/A	N/A	Gutter Slope (%)	N/A
N/A	Gutter Lip Ht (in)	N/A	N/A	Gutter X Slope (%)	N/A
N/A	Painted X Walk1?	No	N/A	Painted X Walk2?	N/A
	X Walk 1 Direction	To SE		X Walk 2 Direction	N/A
N/A	X Walk 1 Width (in)	N/A	N/A	X Walk 2 Width (in)	N/A
	X Walk 1 Slope (%)	4.7		X Walk 2 Slope (%)	N/A
	X Walk 1 X Slope (%)	2.0		X Walk 2 X Slope (%)	N/A

N/A	Ramp inside XWalk1?	N/A	N/A	Ramp inside XWalk2?	N/A
	Road Slope (%)	N/A	N/A	Clear Space?	N/A
	Road X Slope (%)	N/A	N/A	Clear Space to XWalk (in)	N/A
N/A	Any Obstructions?	N/A	N/A	Storm Grate/Utility Hazard?	N/A
	Obstruction Type			Storm Grate/Utility Type	
		N/A			N/A
			Yes	Surface Condition? (G/P)	Good

**Remove & Replace Entire Ramp.**
