# Access Compliance Report

## Public Rights-of-Way

### (Curb Ramps)

Intersection ID: 48642	Main Street: BROCK_RN	Cross Street: EASTFIELD_VILLAGE_LN	Location: E
ADA ID: F74DA6D235CD	Ramp Type: Perp	Initial Pass/Fail: Fail	Overall Compliance: No
Severity Score: 13.75			
Codes/Mitigation Info/Possible Solution		Field Measurements/Component Compliance

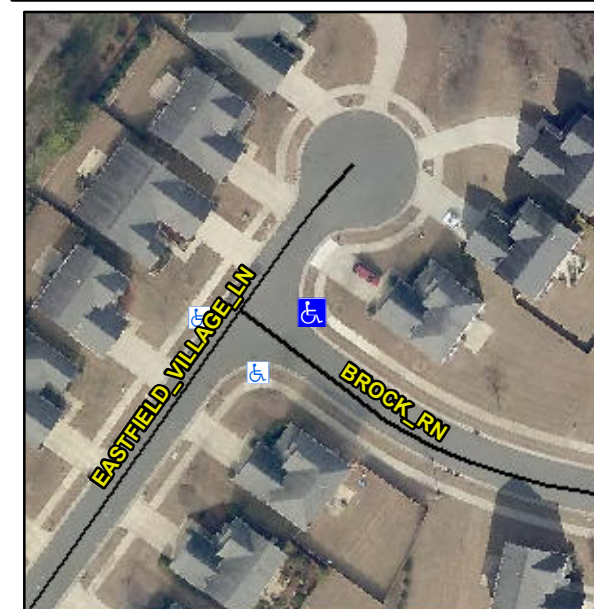
**Not Found, R304.2.2, R304.5.3**

Compliance	Description	Data	Compliance	Description	Data
N/A	Ramp Length (in)	71.0	No	Ramp Slope (%)	8.6
Yes	Ramp Width (in)	48.0	No	Ramp XSlope (%)	2.8
N/A	Flare Type LT	N/A	N/A	Flare Type RT	N/A
N/A	Flare Slope LT (%)	N/A	N/A	Flare Slope RT (%)	N/A
N/A	Flare Traversable LT?	N/A	N/A	Flare Traversable RT?	N/A
N/A	Landing Length (in)	N/A	N/A	DWS Provided?	N/A
N/A	Landing Width (in)	N/A	N/A	DWS Contrast?	N/A
N/A	Landing Slope (%)	N/A	N/A	DWS Length (in)	N/A
N/A	Landing X Slope (%)	N/A	N/A	DWS Full Width?	N/A
N/A	Landing Curb? (Y/N)	N/A	N/A	DWS Offset (in)	N/A
N/A	Shared Landing?	N/A			
N/A	Gutter Ponding?	N/A	N/A	Gutter Slope (%)	N/A
N/A	Gutter Lip Ht (in)	N/A	N/A	Gutter X Slope (%)	N/A
N/A	Painted X Walk1?	No	N/A	Painted X Walk2?	N/A
	X Walk 1 Direction	To SW		X Walk 2 Direction	N/A
N/A	X Walk 1 Width (in)	N/A	N/A	X Walk 2 Width (in)	N/A
	X Walk 1 Slope (%)	2.3		X Walk 2 Slope (%)	N/A
	X Walk 1 X Slope (%)	2.1		X Walk 2 X Slope (%)	N/A

N/A	Ramp inside XWalk1?	N/A	N/A	Ramp inside XWalk2?	N/A
	Road Slope (%)	N/A	N/A	Clear Space?	N/A
	Road X Slope (%)	N/A	N/A	Clear Space to XWalk (in)	N/A
N/A	Any Obstructions?	N/A	N/A	Storm Grate/Utility Hazard?	N/A
	Obstruction Type			Storm Grate/Utility Type	
		N/A			N/A
			Yes	Surface Condition? (G/P)	Good

**Remove & Replace Entire Ramp.**

Total Cost: \$ 1850.00
