# Access Compliance Report

## Public Rights-of-Way

| Intersection ID: 27333 | Main Street: BALLANTYNE_MEDICAL_PL | Cross Street: BRIXHAM_HILL_AV | Location: NE |
| ADA ID: F7526C1620AF | Ramp Type: Perp | Initial Pass/Fail: Fail | Overall Compliance: No |

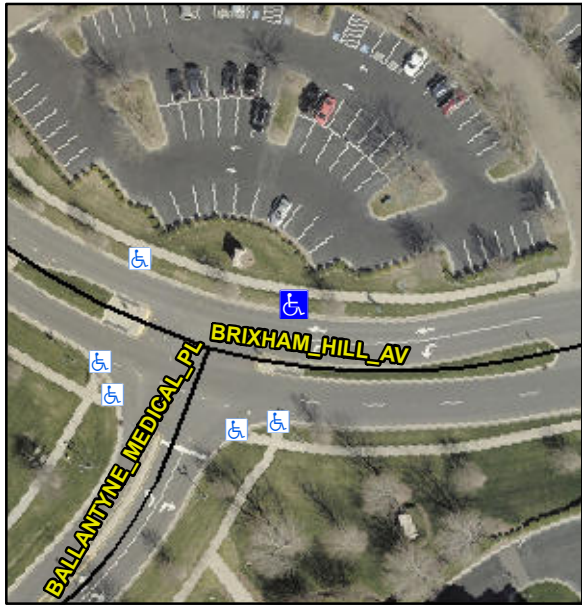
| Codes/Mitigation Info/Possible Solution | | Field Measurements/Component Compliance | | | | | | |
|---|---|---|---|---|---|---|---|---|
| | <b>Remove &amp; Replace Entire Ramp.</b> | | N/A | Ramp Length (in) | 96.0 | No | Ramp Slope (%) | 8.6 |
| PROW/ADA: | | Not Found, R304.2.2 | N/A | Shared Landing? | N/A | | | |

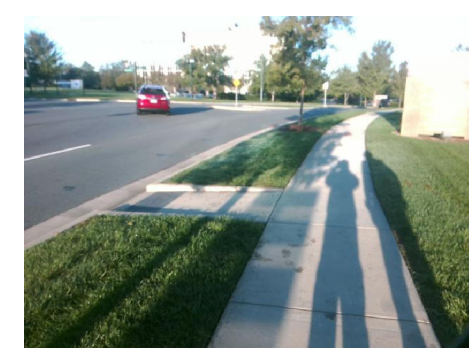
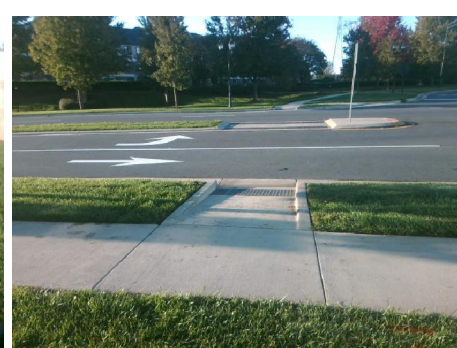
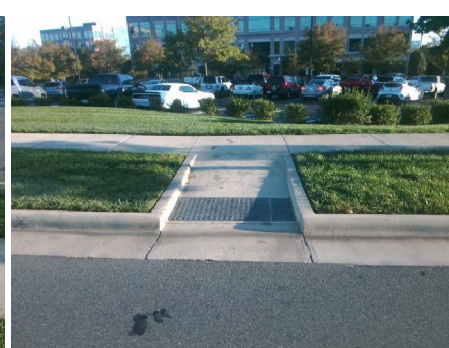
| Codes/Mitigation Info/Possible Solution | | Field Measurements/Component Compliance | | | | | | |
|---|---|---|---|---|---|---|---|---|
| | | | Yes | Ramp Width (in) | 59.0 | Yes | Ramp XSlope (%) | 1.7 |
| | | | | | | Yes | Surface Condition? (G/P) | Good |
