Access Compliance Report

Public Rights-of-Way

(Curb Ramps)

Intersection ID: 27965	Main Street: BALLANTYNE_COUNTRY_CLUB_DR	Cross Street: POUND_HILL_LN	Location: S
ADA ID: F7570D25E2DB	Ramp Type: Perp	Initial Pass/Fail: Fail	Overall Compliance: No
			Severity Score: 1.25
Codes/Mitigation Info/Possible Solution		Field Measurements/Component Compliance

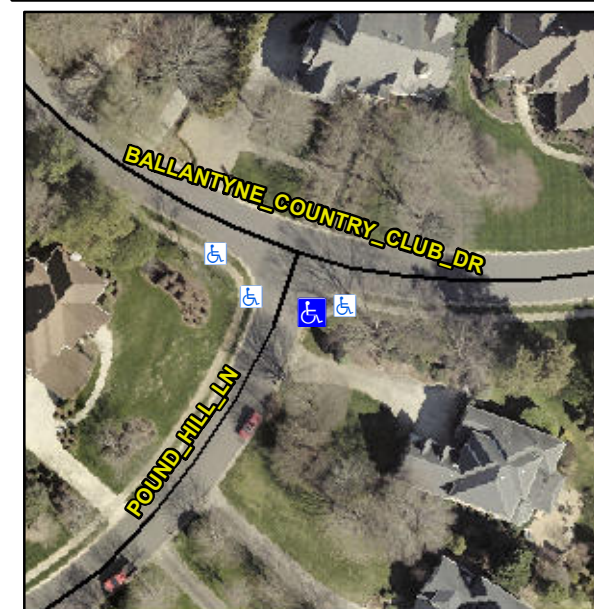
Not Found, R304.5.3

Compliance	Description	Data	Compliance	Description	Data
N/A	Ramp Length (in)	91.0	Yes	Ramp Slope (%)	7.1
Yes	Ramp Width (in)	48.0	No	Ramp XSlope (%)	3.7
N/A	Flare Type LT	N/A	N/A	Flare Type RT	N/A
N/A	Flare Slope LT (%)	N/A	N/A	Flare Slope RT (%)	N/A
N/A	Flare Traversable LT?	N/A	N/A	Flare Traversable RT?	N/A
N/A	Landing Length (in)	N/A	N/A	DWS Provided?	N/A
N/A	Landing Width (in)	N/A	N/A	DWS Contrast?	N/A
N/A	Landing Slope (%)	N/A	N/A	DWS Length (in)	N/A
N/A	Landing X Slope (%)	N/A	N/A	DWS Full Width?	N/A
N/A	Landing Curb? (Y/N)	N/A	N/A	DWS Offset (in)	N/A
N/A	Shared Landing?	N/A			
N/A	Gutter Ponding?	N/A	N/A	Gutter Slope (%)	N/A
N/A	Gutter Lip Ht (in)	N/A	N/A	Gutter X Slope (%)	N/A
N/A	Painted X Walk1?	No	N/A	Painted X Walk2?	N/A
	X Walk 1 Direction	To NW		X Walk 2 Direction	N/A
N/A	X Walk 1 Width (in)	N/A	N/A	X Walk 2 Width (in)	N/A
	X Walk 1 Slope (%)	2.7		X Walk 2 Slope (%)	N/A
	X Walk 1 X Slope (%)	1.6		X Walk 2 X Slope (%)	N/A

N/A	Ramp inside XWalk1?	N/A	N/A	Ramp inside XWalk2?	N/A
	Road Slope (%)	N/A	N/A	Clear Space?	N/A
	Road X Slope (%)	N/A	N/A	Clear Space to XWalk (in)	N/A
N/A	Any Obstructions?	N/A	N/A	Storm Grate/Utility Hazard?	N/A
	Obstruction Type			Storm Grate/Utility Type	
		N/A			N/A
			Yes	Surface Condition? (G/P)	Good

Possible Solutions:

Remove & Replace Entire Ramp.
