Access Compliance Report

Public Rights-of-Way

(Curb Ramps)

Intersection ID: 53351	Main Street: MARVIN_RD	Cross Street: SAPPHIRE_HILL_LN	Location: NW
ADA ID: F76E6CEDC1E1	Ramp Type: Perp	Initial Pass/Fail: Fail	Overall Compliance: No
Severity Score: 33.75			
Codes/Mitigation Info/Possible Solution		Field Measurements/Component Compliance

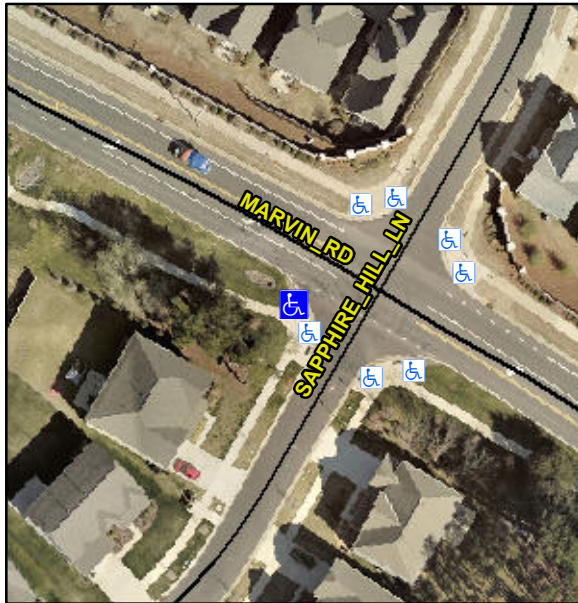
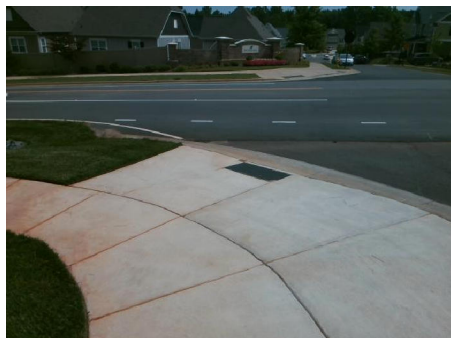
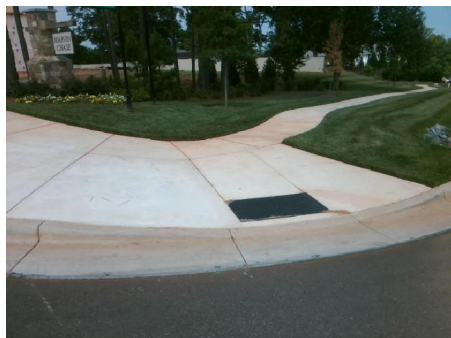
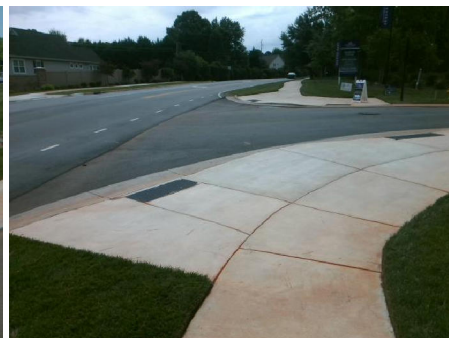
Not Found, R304.5.1, R304.5.3

Compliance	Description	Data	Compliance	Description	Data
N/A	Ramp Length (in)	105.0	Yes	Ramp Slope (%)	7.1
No	Ramp Width (in)	47.0	No	Ramp XSlope (%)	7.4
N/A	Flare Type LT	N/A	N/A	Flare Type RT	N/A
N/A	Flare Slope LT (%)	N/A	N/A	Flare Slope RT (%)	N/A
N/A	Flare Traversable LT?	N/A	N/A	Flare Traversable RT?	N/A
N/A	Landing Length (in)	N/A	N/A	DWS Provided?	N/A
N/A	Landing Width (in)	N/A	N/A	DWS Contrast?	N/A
N/A	Landing Slope (%)	N/A	N/A	DWS Length (in)	N/A
N/A	Landing X Slope (%)	N/A	N/A	DWS Full Width?	N/A
N/A	Landing Curb? (Y/N)	N/A	N/A	DWS Offset (in)	N/A
N/A	Shared Landing?	N/A			
N/A	Gutter Ponding?	N/A	N/A	Gutter Slope (%)	N/A
N/A	Gutter Lip Ht (in)	1.0	N/A	Gutter X Slope (%)	N/A
N/A	Painted X Walk1?	No	N/A	Painted X Walk2?	N/A
	X Walk 1 Direction	To NE		X Walk 2 Direction	N/A
N/A	X Walk 1 Width (in)	N/A	N/A	X Walk 2 Width (in)	N/A
	X Walk 1 Slope (%)	8.7		X Walk 2 Slope (%)	N/A
	X Walk 1 X Slope (%)	3.6		X Walk 2 X Slope (%)	N/A

N/A	Ramp inside XWalk1?	N/A	N/A	Ramp inside XWalk2?	N/A
	Road Slope (%)	N/A	N/A	Clear Space?	N/A
	Road X Slope (%)	N/A	N/A	Clear Space to XWalk (in)	N/A
N/A	Any Obstructions?	N/A	N/A	Storm Grate/Utility Hazard?	N/A
	Obstruction Type			Storm Grate/Utility Type	
		N/A			N/A
			Yes	Surface Condition? (G/P)	Good

Possible Solutions:

Remove & Replace Entire Ramp.
