Access Compliance Report Public Rights-of-Way (Curb Ramps)

Intersection ID: 21348	Main Street: CARMEL_RD			Street:	SHARON_VIEW_RD	Location:	NW		
ADA ID: F781AC7250F4	Ramp Ty	Ramp Type: PerpDiag		Initial Pass/Fail: Fail Overall Compliance: No				o Severity Score:	25
Codes/Mitigation Info/Possible Solution				Field Measurements/Component Compliance					
		Possible Solutions:		Compliance Description			Data Compliance Description		
		Remove & Replace Curb Ramp W	/ith	N/A	Ramp Length (in)	48.0	No	Ramp Slope (%)	10.4
		Two New Directional Ramps or Equivalent.		Yes	Ramp Width (in)	48.0	No	Ramp XSlope (%)	5.6
the the al				N/A	Flare Type LT	N/A	N/A	Flare Type RT	N/A
				N/A	Flare Slope LT (%)	N/A	N/A	Flare Slope RT (%)	N/A
	A PERMIT			N/A	Flare Traversable LT?	N/A	N/A	Flare Traversable RT?	N/A
				N/A	Landing Length (in)	N/A	N/A	DWS Provided?	N/A
A COLORADO AND		Surveyor Notes:		N/A	Landing Width (in)	N/A	N/A	DWS Contrast?	N/A

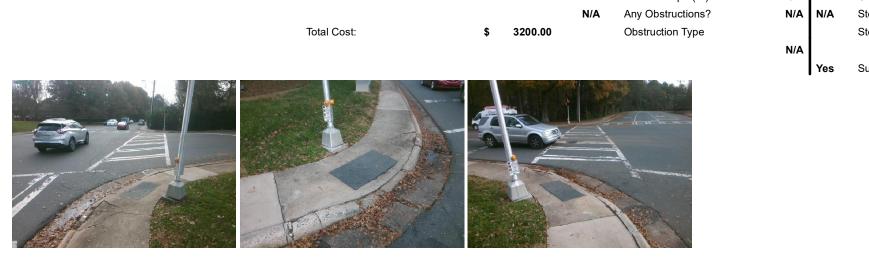
t.	6 NA	N/A		N/A	Landing Slope (%)	N/A	N/A	DWS Length (in)	N/A
SHARON_VIEW_RD				N/A	Landing X Slope (%)	N/A	N/A	DWS Full Width?	N/A
The state of the s	, EL			N/A	Landing Curb? (Y/N)	N/A	N/A	DWS Offset (in)	N/A
E I	E C			N/A	Shared Landing?	N/A			
6 31 /10	A. California	PROW/ADA:		N/A	Gutter Ponding?	N/A	N/A	Gutter Slope (%)	N/A
	Not Found, R304.2.2, R304.5.3		N/A	Gutter Lip Ht (in)	N/A	N/A	Gutter X Slope (%)	N/A	
				N/A	Painted X Walk1?	Yes	N/A	Painted X Walk2?	Yes
					X Walk 1 Direction	To SW		X Walk 2 Direction	To SE
				N/A	X Walk 1 Width (in)	118.0	N/A	X Walk 2 Width (in)	134.0
Street 1 Name	SHARON VIEW RD				X Walk 1 Slope (%)	5.8		X Walk 2 Slope (%)	7.5
Stop Condition-Street 2	Signal				X Walk 1 X Slope (%)	4.8		X Walk 2 X Slope (%)	4.8
Street 2 Name	CARMEL RD			N/A	Ramp inside XWalk1?	Yes	N/A	Ramp inside XWalk2?	Yes
Stop Condition-Street 1	Signal				Road Slope (%)	1.3	N/A	Clear Space?	N/A
					Road X Slope (%)	9.4	N/A	Clear Space to XWalk (in)	N/A

N/A	Any Obstructions?	N/A	N/A	Storm Grate/Utility Hazard?	N/A
		Total Cost: \$ 32	200.00		Obstruction Type			Storm Grate/Utility Type	
						N/A			N/A
